Memorial Auditorium

Burlington, Vermont

Historic Preservation Report

June 14, 1996

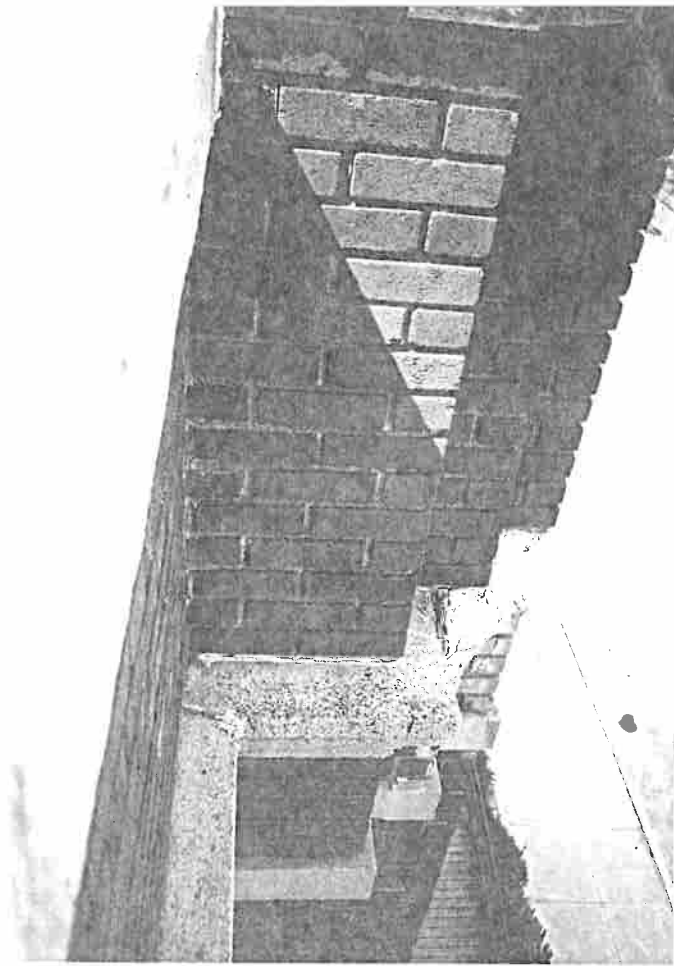
Condition: Fair. Concrete has completely deteriorated at several corners along the beltcourse above the third story windows (specifically at the southeast corner of the southwest tower, at the southeast corner of the northeast tower, and at the northeast corner of the northwest tower). It appears that these areas were inappropriately repaired with a substitute material (see Figure 1). The northwest corner of the foundation is spalling. Some of the concrete blocks at the foundation of the stairs to the northeast lobby entrance may need to be reset due to settling (see Figure 2).

Figure 1 - View of concrete beltcourse taken from the roof.

Treatment: A leaking roof may have been the original cause for deterioration at the upper beltcourse, but the leak may no longer be active. The preferable treatment for these areas is to remove the damaged sections and replace them

with similar concrete elements. It is possible to recast sections of the beltcourse in place, but due to the poor condition of the substrate, this repair may only last a few years.

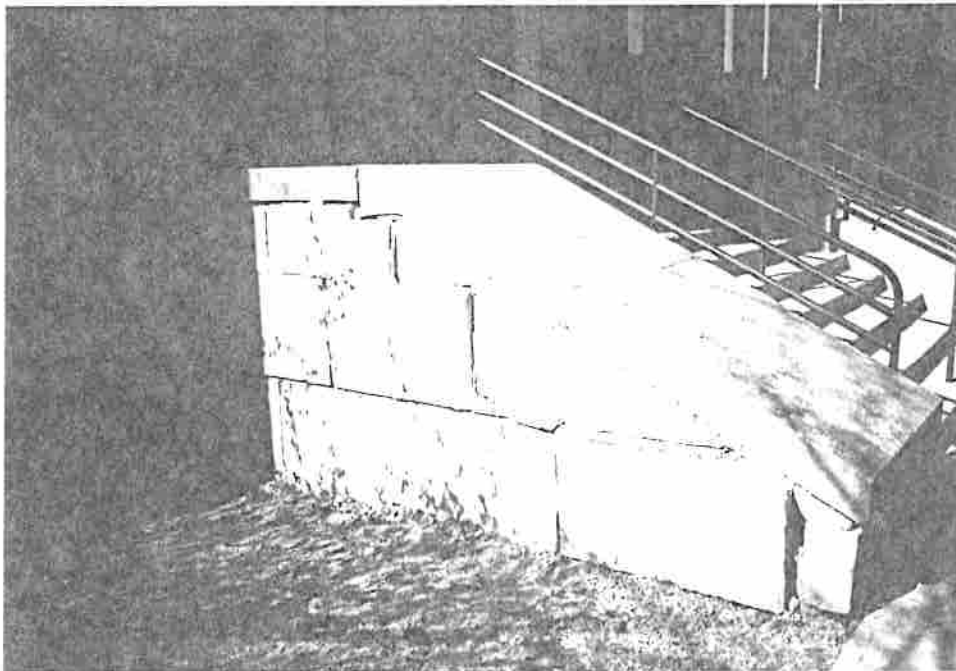
Figure 2 - View of the foundation blocks at the north lobby entrance.

The northwest corner of the foundation can be patched. All spalling concrete should be removed before a compatible patch material is used. It is important that the new concrete match the original as closely as possible so that the properties of the two materials, such as coefficient of thermal expansion and strength, are compatible enough to prevent future cracking. If the concrete contains rebars, rust should be removed from them with a wire brush before they are coated with an epoxy and patched. (See page 8 of Preservation Brief 15 for a detailed description).

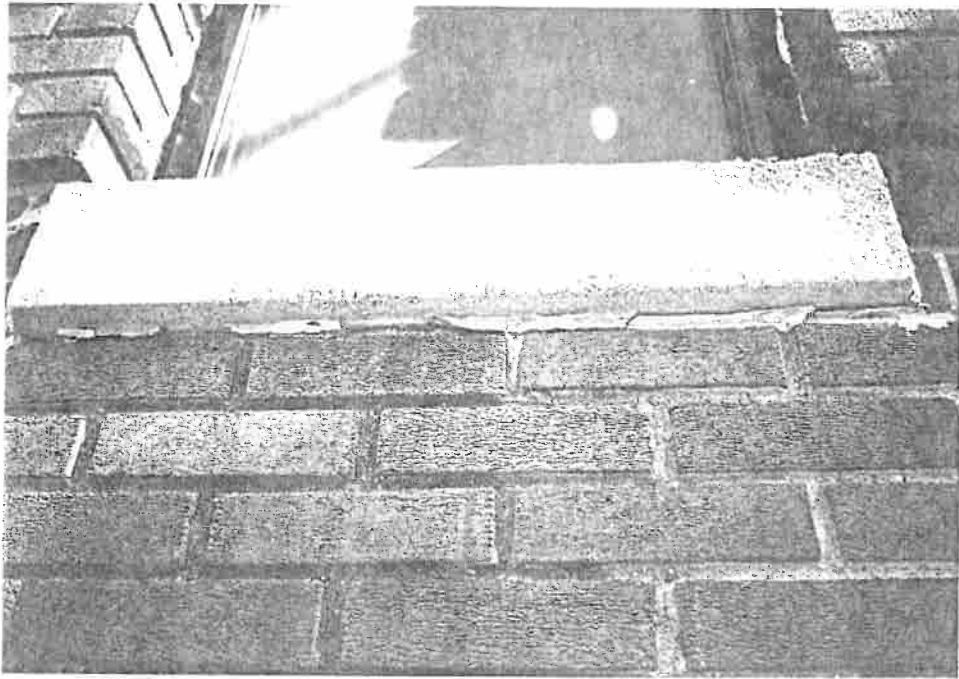
Condition: Fair to poor. The mortar has failed around many concrete features (in particular, around the window sills, between the foundation blocks at the front facade and lobby steps, between the molding that surrounds the lobby doors, and along the beltcourses). Many of these areas have been patched inappropriately with caulking compound in an effort to prevent further damage (see Figure 3).

Figure 3 - View of a concrete sill on the exterior of the building. Notice the caulking that was used to patch failed mortar around the sill.

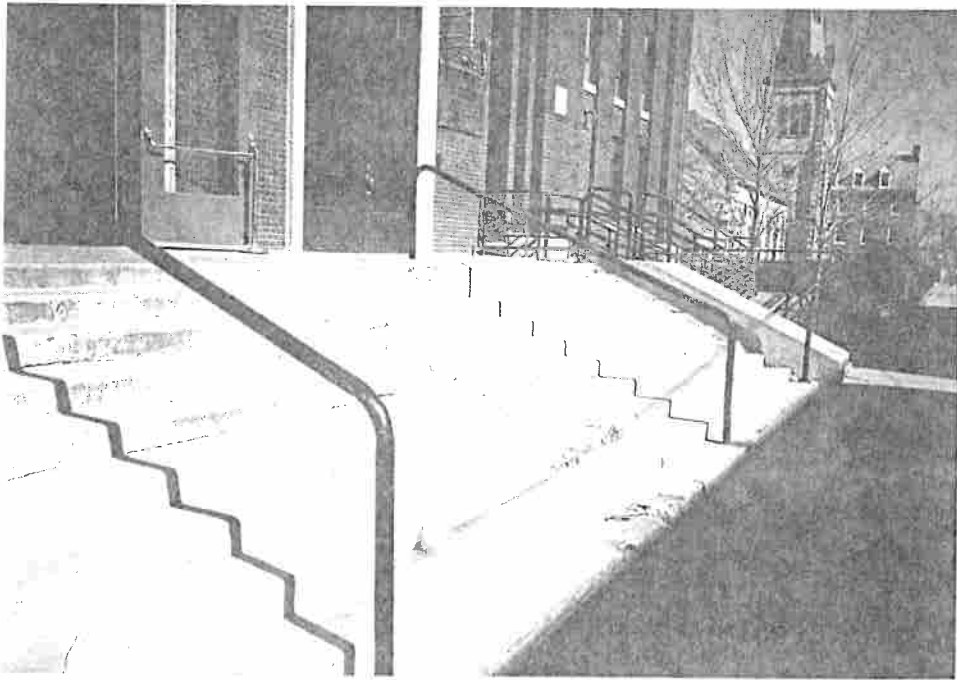
Condition: Fair to poor. The steps leading to the north and south entrances to the lobby are in good condition, but those at the front entrance to the lobby are chipped and fractured in several areas (see Figure 4). A quarter-inch coat of painted concrete covers what appears to be the original concrete.

Figure 4 - View of the front steps to the lobby.

Treatment: Remove deteriorated concrete until the substrate is solid. If the bond between the first patch coat and original concrete is not strong, the first patch coat may have to be removed entirely. When a solid substrate is reached, the steps should be patched with a compatible material and repainted with a masonry sealant. Sand can be applied to the paint to increase traction on stairs. Measures should be taken in the future to protect steps when equipment is loaded and unloaded for performances.

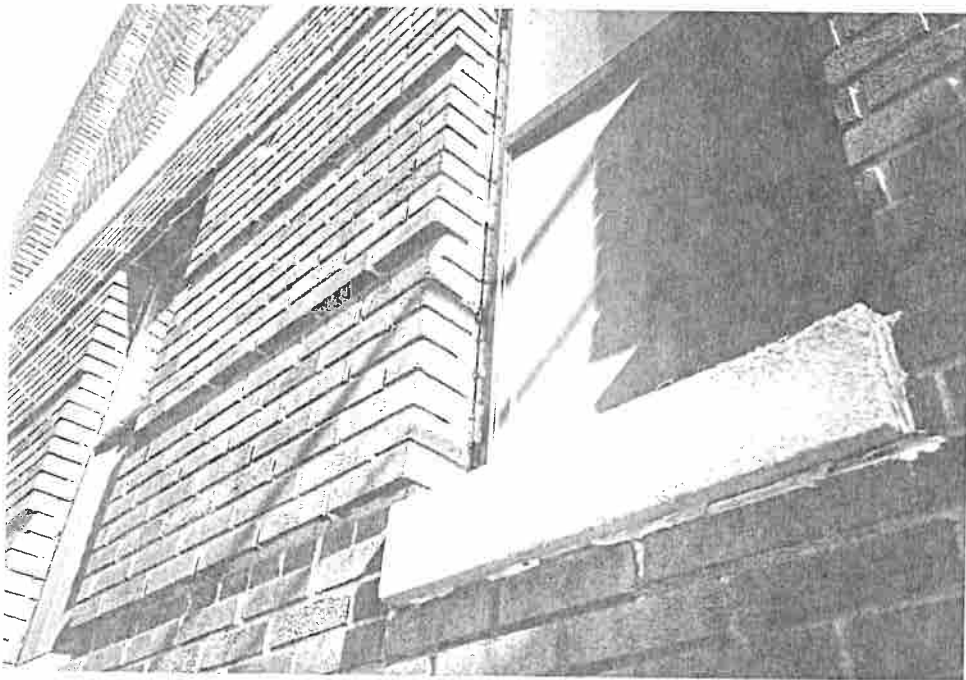
Condition: Good. Although these windows do not accurately replicate the historic ones they replaced, they are in fine condition. However, many have a space between their outer frame and the masonry that needs to be caulked (see Figure 5).

Figure 5 - This photo illustrates the need for caulking around some of the replacement windows.
