Re: Memorial Auditorium
Burlington, VT

RE: Memorial Auditorium Weathering Analysis

SUGGESTED PRIORITY LIST FOR REHABILITATION OF
MEMORIAL AUDITORIUM EXTERIOR

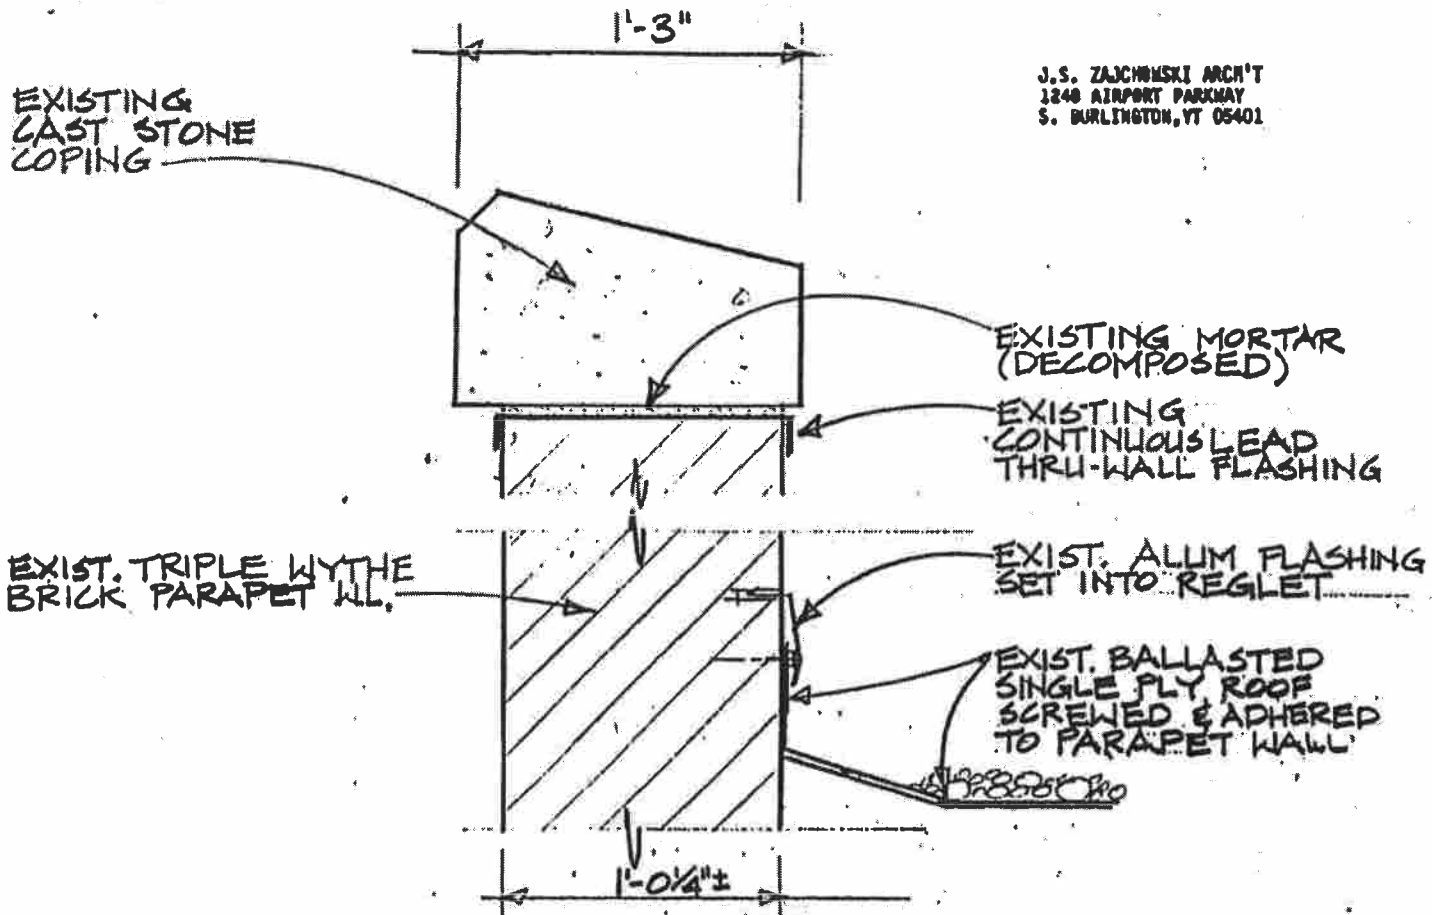
Ⓐ TYPICAL PARAPET WALL
SCALE: 1/2" = 1'-0"

- Parapet wall is constructed of solid brick and is a nominal 12" thick wall. (Photo 1 and 2, and Sketch A).
- Wall is capped with a continuous through wall lead cap flashing turned down approximately 1 1/4" at each face of wall, creating a drip edge. (Sketch A and B).

- In all instances the mortar course between the lead flashing and coping cap was completely decomposed and could be brushed off like loose sand. From observation of coping caps that were not removed, the condition of mortar beneath them appears to be the same as for those which were removed. (Photo 3, 4, and 5).

EXISTING MORTAR
(DECOMPOSED)

EXISTING
CONTINUOUS LEAD
THRU-WALL FLASHING

EXIST. TRIPLE WYTHE
BRICK PARAPET WL.

EXIST. ALUM FLASHING
SET INTO REGLET

EXIST. BALLASTED
SINGLE PLY ROOF
SCREWED & ADHERED
TO PARAPET WALL

- Re-set all cast stone coping and repair pieces that are damaged.
- Repair all portions of cast stone bands that are decomposed.
- Re-mortar all joints in cast stone coping and bands and seal with a long life sealant.
- Re-point any masonry mortar joints that require pointing.
- Replace steel lintels whose condition dictates replacement.
- Replace or repair steel windows as necessary - many are rusted, many are leaking.
- After cleaning all masonry by a non abrasive cleaning method, seal all masonry and cast stone with a water repellent coating.
- Perform corrective work to single ply roofing, especially at wall flashing where material is pulling away from wall attachment.

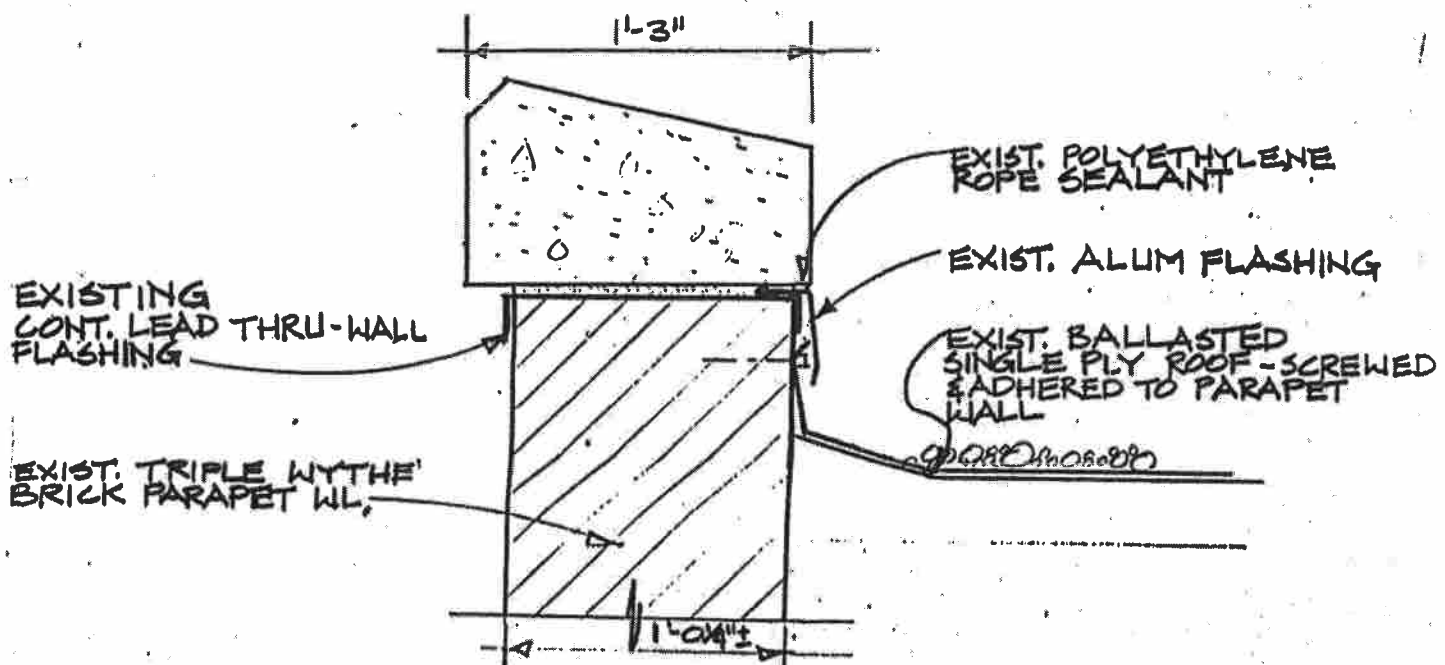
Ⓑ TYPICAL LOW PARAPET WL. - SOUTH SIDE
SCALE: 1/2" = 1'-0"

- In nearly all instances the joints between sections of coping were in very poor condition, with deteriorated mortar, and those that had been caulked, with split caulking and poor improper caulking. (Photo 5 and 6).
- At the coping removed at the south wall, the aluminum counter flashing installed during the single ply roofing installation had been placed over the lead through wall flashing. This would allow water seeping through the coping and coping joints to run down behind the single ply roofing where it has pulled away from the building wall. (Sketch B and Photo 7).

EXISTING
CONT. LEAD THRU-WALL
FLASHING

EXIST. POLYETHYLENE
ROPE SEALANT

EXIST. ALUM FLASHING

EXIST. TRIPLE WYTHE
BRICK PARAPET WL.

EXIST. BALLASTED
SINGLE PLY ROOF - SCREWED
& ADHERED TO PARAPET
WALL
