# Memorial Auditorium

October 13, 2015

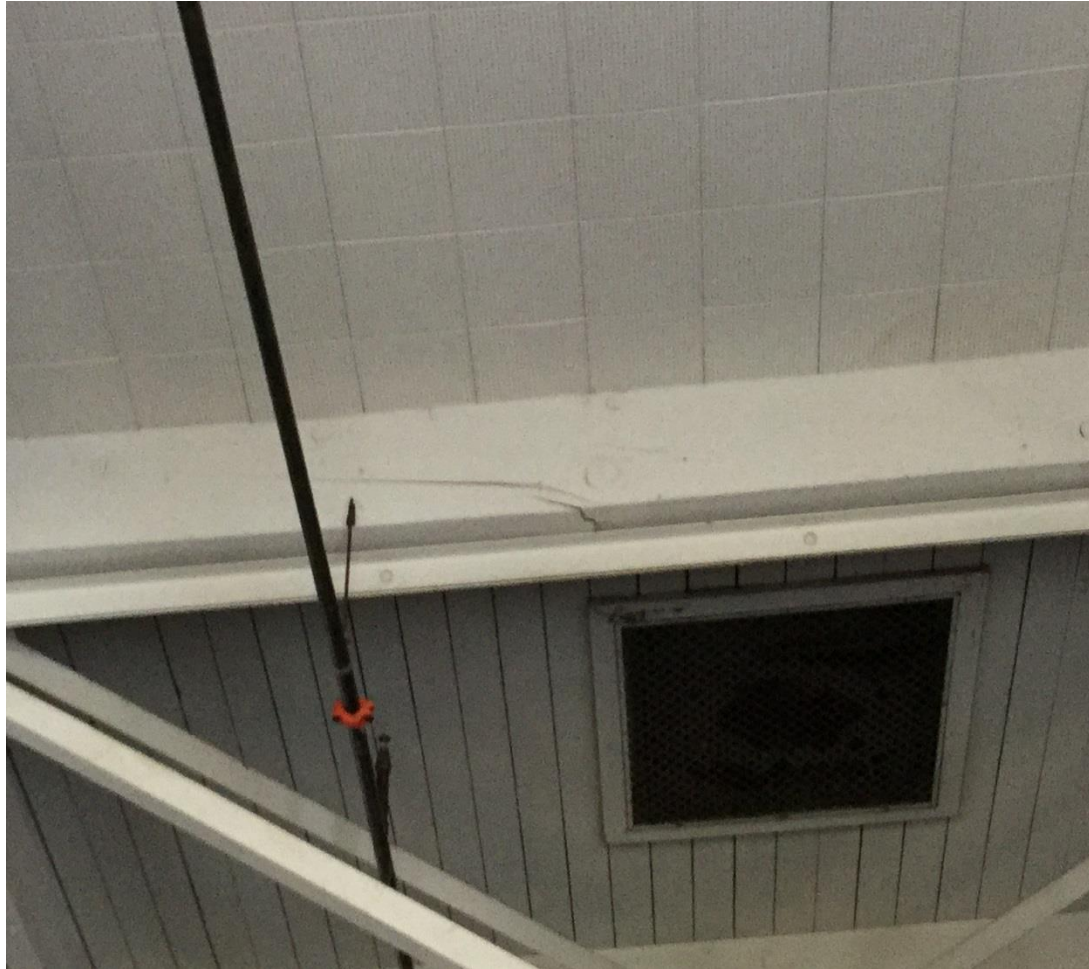
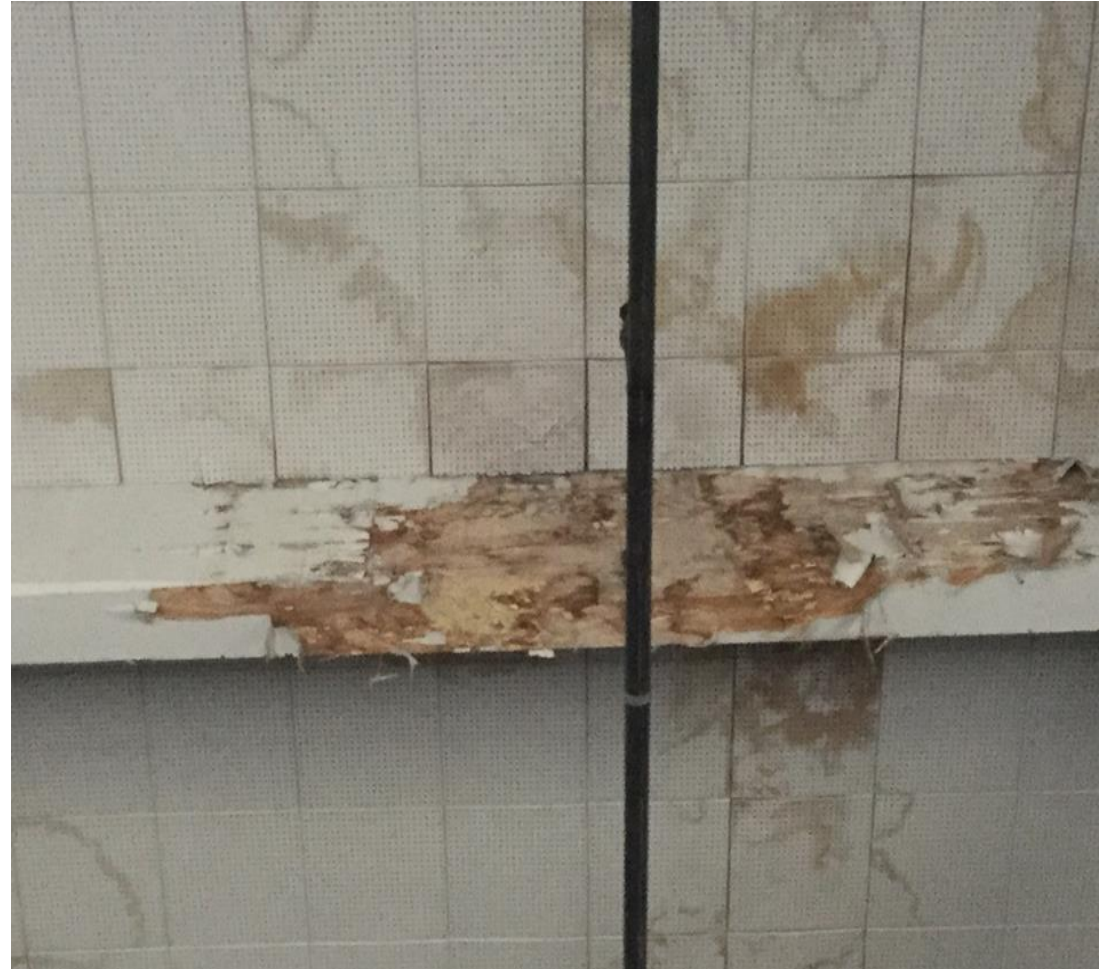
# Damaged roof decking – 3” x 5” planks

photo 2015
