Preliminary Structural Report

36 Convent Square

Burlington, Vermont

January 29th, 2010

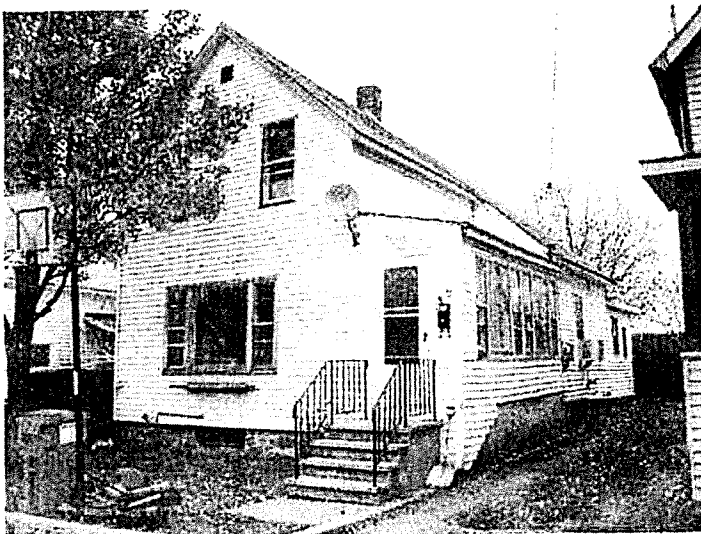
View of front elevation looking easterly.

The molded cornice is one of few remaining historic elements.

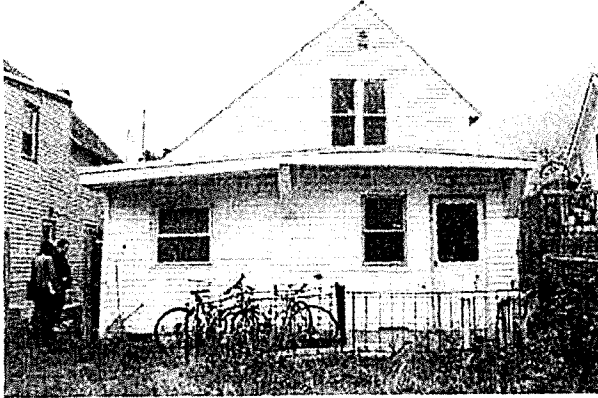
Rear elevation, showing non-historic rear addition.

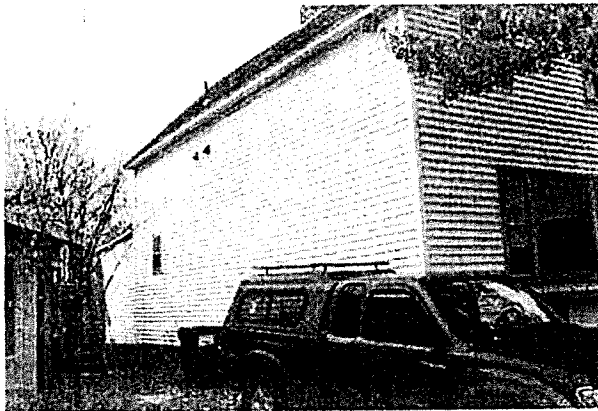
The north elevation has only 1 window, most likely others were removed or covered over.

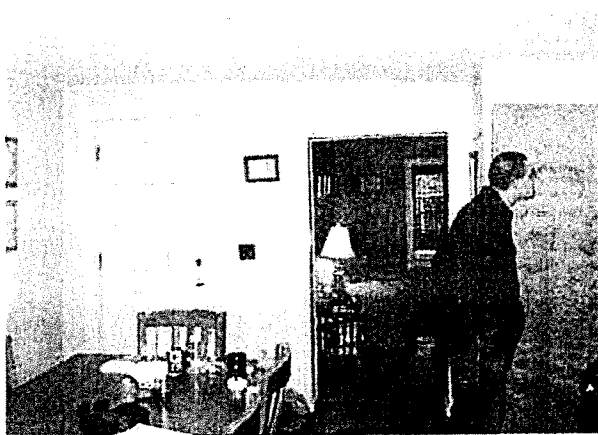
Typical interior view showing modern finishes.
