Burlington Bike Path Intersections Scoping Study

In the City of Burlington, Vermont

January 20, 2014

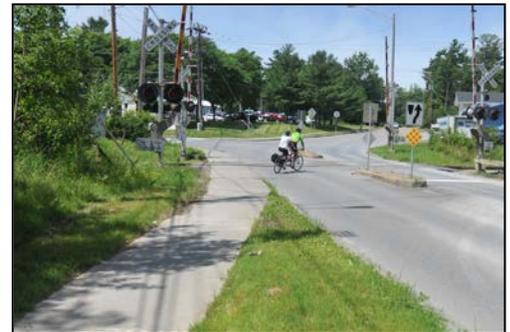
Tandem cyclists unsafely crossing the railroad tracks at a skewed angle

Wayfinding at this crossing is very limited and an unfamiliar path user would likely struggle to follow the Burlington Bike Path down Austin Drive to the next off-road section of the path. Likewise, the entrance to the path at the Home Avenue intersection is not well marked.

The existing pedestrian facilities in this area include sidewalks which are in very poor condition and are unsafe. Home Avenue and Austin Drive do not have dedicated bicycle facilities and lack advisory signage to indicate that these are a bike route and shared road.

Short term solutions at this crossing include enhanced pavement markings, additional wayfinding and signage, and vegetation trimming to improve sightlines. Painted shared lane markings (also known as “sharrows”) should be added to Home Avenue following accepted guidance on spacing and positioning. Other paint marking that should be incorporated to the area includes a “path ends” marking on the path prior to the crossing to warn users that a roadway connection is coming up.

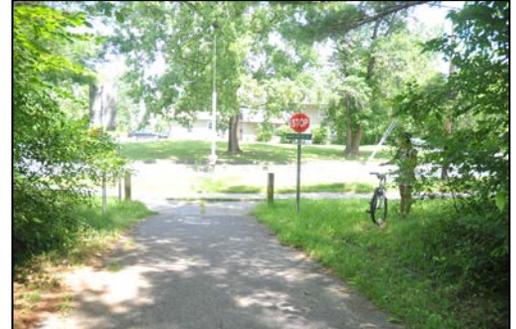
View of Home Avenue from the Bike Path with limited sight distance to the east and west

A wayfinding sign at the intersection of the path and sidewalk should be added so that path users can easily determine where to go to continue along the Burlington Bike Path, which way to go for other local attractions, and how far they’ll need to travel to get there. Existing vegetation and tree branches in the area should be trimmed to improve the existing sight distance. Both of these improvements will also enhance user awareness of this connection and create a more visible entrance to the path for people traveling on Home Avenue.

As long term solutions in this area it is recommended that additional curb cuts be installed from the path and sidewalk to allow cyclists to access Home Avenue at better locations to head east or west. The center median island on Home Avenue should be shortened to accommodate a straight crossing from the path to the north side of Home Avenue. This will allow cyclists to then head west on the road, crossing the tracks at ninety degrees. Along with the additional road connections, the sidewalk should be widened and repaired to better accommodate a mix of cyclists and other path users. Existing path signage should also be modified to include the relocation of the existing stop sign, the addition of a warning sign for cyclists to yield to pedestrians on the sidewalk, and the addition of appropriate roadway warning signs as recommended by the MUTCD. All of these proposed improvements are shown in Figure 1.

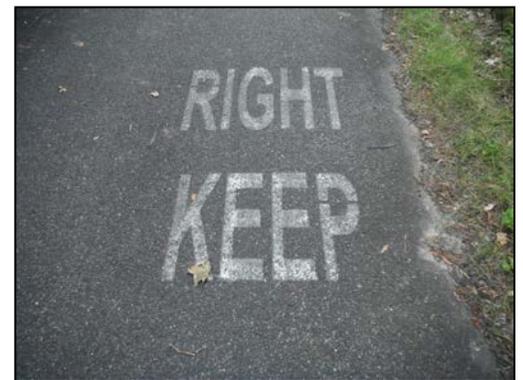
Example of existing pavement markings that can be enhanced as a short term solution

addition, to replace the hazardous boulder in the middle of the path, a splitter island should be designed to prevent motor vehicles from entering the park by the bike path and to also slow cyclist speeds as they enter the intersection of Austin Drive. The splitter island should include a reflectorized removable bollard and flush imprinted pavement as a base. During large scale athletic events, such as the marathon, when many users need to share the path it will be important not to have an obstruction constricting the path width. The existing boulders in the area can be utilized on the outside of the path to define the entrance if desired. Detectable warning surfaces (DWS) should also be added to the crossing in accordance with ADA guidelines similarly to all of the intersections present herein. All of these proposed improvements can be seen on Figure 2 on the following page.

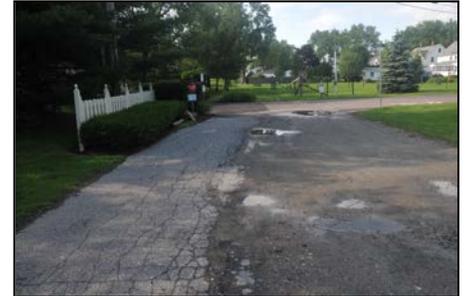
After passing through Oakledge Park the bike path follows along the side of Proctor Place and then connects to a final on-road connection at Harrison Avenue. As the path follows Proctor Place there is no distinct definition of the path as opposed to the roadway. The path is paved whereas the road is gravel which leads to stormwater and runoff expediting the deterioration of the edge of the path in this area. This also leads to cyclists and vehicles sharing both the road and the path which creates more potential for conflict.

Path deterioration and sight distance restrictions at Harrison Avenue

Short term solutions near the western crossing of Harrison Avenue include similar treatments as other intersections such as paint markings, sign improvements, and vegetation trimming. Coordination with the Harbor Watch community should take place to either trim existing vegetation along the fence line at the corner of their property or to replace it with lower lying bushes that would not restrict sight distance. Signs in the area should be updated to be consistent with other similar warning signs at the intersections. The westbound sharrow should be replaced with more appropriate bike symbol and arrow markings to help reinforce the message that there is a path entrance at Proctor Place. Other paint markings that should be incorporated include a centerline stripe on the bike path, edge of path lines to delineate the path, and possibly green paint on the bike path to provide even more visual separation from Proctor Place.

As a long term improvement it is recommended that the City pave the entrance to Proctor Place. This would allow improved path/roadway delineation and also improve drainage and runoff at the intersection. If possible all of Proctor Place should be paved to prevent the path deterioration that is evident today. All of these proposed improvements are shown in Figure 3.

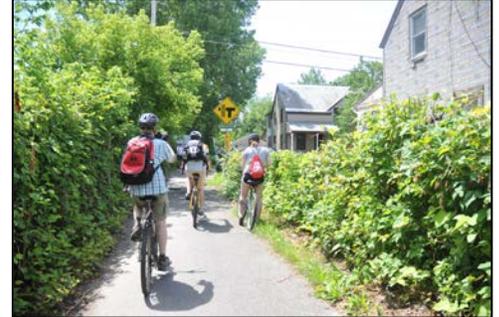
The eastern access of the bike path at Harrison Avenue connects the on-road portion of the path with the standard path near the railroad track crossing to Sears Lane. This crossing is unique in that the path doesn't necessarily cross or intersect Harrison Avenue, but rather it merges into it or continues off the road depending on the direction of travel. There is currently no stop or yield sign at this location as there is no direct crossing, but warning signs exist in the area to create awareness of the roadway and nearby railroad. As path users enter and exit this access point to the path, there is often conflict among users and congestion as the entry of the connection is narrow. These conflicts combined with the deficient guardrail and lack of paint markings at the access point create a potentially hazardous location for all path users.

Multiple users near Harrison Avenue navigating narrow corridor and congestion

Short term solutions at the eastern connection to Harrison Avenue include enhanced wayfinding, signage, and paint markings. As cyclists or other path users head east on Harrison Avenue, it is unclear where the bike path connection is. This location should utilize larger wayfinding signs to allow ample guidance to users and to let them know they are still on the correct route. In addition, paint markings on the roadway can help to eliminate confusion in the area. It is recommended that a centerline be painted extending from the path to the road so as to keep users in the right hand travel lane. This should be supplemented with painted bike symbols and arrows to reiterate the direction of travel. Signs should be updated consistently with other crossings as shown in Figure 4 on the next page.

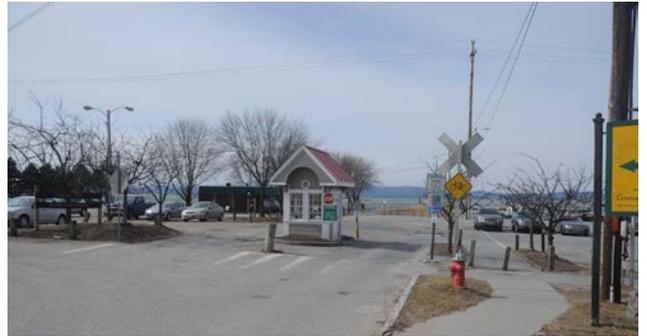
The path at this crossing is stop controlled and there is also an existing stop sign for vehicles traveling east out of the Perkins Pier lot. Other signs include two W11-1 signs prior to the path to warn westbound vehicles. Existing utilities on the northern path approach to this intersection also limit path realignment options.

Minimal path delineation makes it unclear where path users should safely travel

Short term recommendations are similar to other intersections in the overall concepts. Path delineation should be improved by adding redefined lines along Railway Lane. Path markings would also include “stop ahead” warnings to the path users to alert them of the intersection.

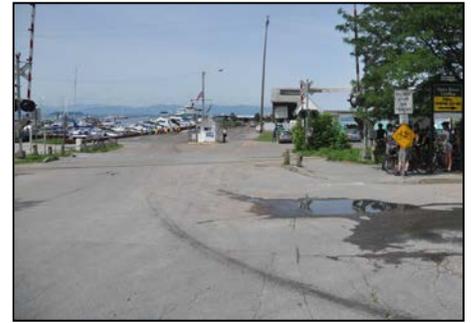
The bike path crossing at King Street is similar to Maple Street in that it is a high volume location for path use and roadway use. This intersection, however, also includes a path railroad crossing on the northern side of King Street. There is also an additional hazard of a low lying wooden guardrail on the north side just east of the railroad tracks. This is intended to deter path users from crossing the railroad track at a skew across the road, but if it goes unseen could remain an even greater hazard to cyclists in the area. The path is currently stop controlled and there are minimal warning signs for vehicles or path users. Path delineation at this crossing consists of a faded crosswalk marking which is unclear to new path users.

Minimal warning signs, path delineation, and the railroad crossing make this intersection one of the most complex

Short term solutions include consistent signage improvements as noted at previous intersections, enhanced path delineation, and additional path warning signs. W10-1 signs and appropriate pavement markings should be added to the path to warn path users of the upcoming crossing. The existing signs in the area for vehicles should be updated appropriately. A repainted crossing and centerline stripes should be added for enhanced delineation so users understand where they should travel and cross the railroad at a ninety degree angle.

The imminent long term recommendation here is to widen the existing path railroad crossing to ten feet and remove the low wooden guardrail to replace it with flexible reflectorized bollards. This will provide a safer environment for multiple users taking the sharp corners and crossing the railroad tracks. The addition of colorized path pavement or green paint could be included to further delineate the path. All of these long and short term recommendations are shown in Figure 6.

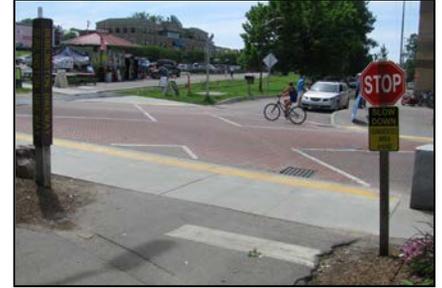
Creemee stand, railroad, sidewalk, and vehicle conflict points shown here

All of these conflict points contribute to potentially hazardous conditions at this crossing. Lack of wayfinding, signage, and path delineation also contribute to the perceived confusion through this area, and these could all be improved upon.

Many short term solutions at this intersection include similar recommendations as previously discussed for other intersections such as consistent signage, wayfinding, and paint markings. Vehicular warning signs should be upgraded to reflect that the path is not only a pedestrian crosswalk, but also for cyclists and other users. The existing W11-2 should be replaced with an appropriate W11-15. Also a R9-6 warning sign for southbound path users should be added to give notice that pedestrians may be crossing on the existing sidewalk and that cyclists should yield. Path markings should include the standard centerline stripe, and the addition of painted lines directing path users where to cross the railroad tracks and the crossing of College Street. Colorized pavement or paint can be used to provide additional visual path delineation. “Stop Ahead” and “RR X-ING” markings should also be painted on the path to provide prior warning. The approximate locations of these are shown on Figure 7 on the following page but should be applied according to MUTCD guidance.

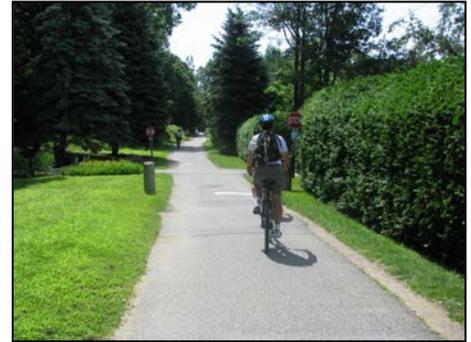
The primary concern at this location is that the driveway is screened by a dense row of high arborvitae that runs parallel to the path. Our observation is that path users ignore the stop signs since the motor vehicle traffic volumes and speeds on Little Eagle Bay are so low. These conditions result in a feeling by the cyclists that there is little inherent danger and some may slow down, but most do not stop.

Tall hedges restrict sight distance at Little Eagle Bay

The primary near term solution is to eliminate the stop signs on the path. It is recommended that the stop signs be moved to the roadway instead. Yield signs would not be placed on the path since the roadway would be stop controlled and stop and yield signs are not placed within the same intersection per national guidance. Road crossing warning signs and pavement markings would also be added on the path near term, and “recreation path crossing” signs would be added to Little Eagle Bay drive to alert motorists. Standard crosswalk markings and stop bars would also be added. The installation of a convex driveway mirror is also suggested to help motorists exit the drive and help cyclists see whether there is a car approaching.

Long term recommendations include shifting the path a few feet east away from the hedgerow to improve the ability of motorists to see oncoming bikes. This would likely be accomplished under the overall Bike Path Rehabilitation Project. There is a concern that the alignment shift might not be allowed since there is already a court decision in place that limits the path width to 8 feet in this area. That decision also prohibits hedge and tree trimming and if the shift impacts the adjacent spruce trees it would likely not be allowed. All of these proposed improvements are shown in Figure 8.

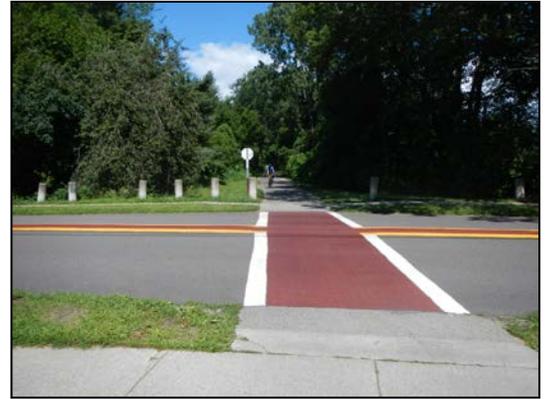
Traffic calming measures and existing conditions as seen at Shore Road

The primary consideration at this crossing is that many cyclists roll through the stop signs as opposed to coming to a complete stop. There is reportedly no crash history related to this behavior, and we observed some motorists stopping before crossing the crosswalk to make sure no bikes were coming. Motorists are required by law to yield to pedestrians at the crosswalks but they are not required to yield to bikes unless the bikes are already in their path in the crosswalks or unless the cyclist dismounts and crosses the road on foot.

The short term improvements that are recommended at this location primarily include adding solid yellow centerline striping and new stop bars on the path, adding “stop ahead” markings on the path, and adding new W11-15 with W16-7P crossing signs on the street close to the crossing. Yield to ped signs (R9-6) would also be installed on the path in advance of the crossing since the path crosses the sidewalks before crossing the street. Vegetation clearing is recommended at the four corners to the extent possible within the right-of-way to improve sight lines.

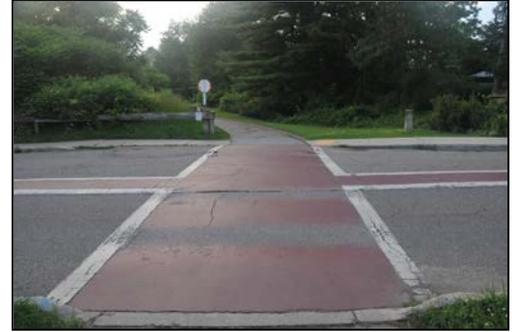
The Staniford Road crossing is very similar to the Shore Road crossing. Staniford Road does not have a sidewalk on the south side but does include a sidewalk on the north side. In addition, the path is slightly curved on both approaches, and the northwest quadrant contains a large vegetated earth mound that limits sight distance to the west. There is also a side street, Appletree Place, which enters Staniford Road at a skew angle less than 100 feet away from the path crossing. All of these differences make this crossing less of a candidate for bike yield control.

Existing conditions at Staniford Road including traffic calming and sight distance concerns

The recommended short term improvements at this location primarily include adding solid yellow centerline striping and new stop bars on the path, adding “stop ahead” markings on the path, and adding new W11-15 with W16-7P crossing signs on the street close to the crossing. An additional W11-15 with W11-15P sign package should be added along Apple Tree Bay Road. Vegetation clearing is recommended at the four corners to the extent possible within the right-of-way to improve sight lines.

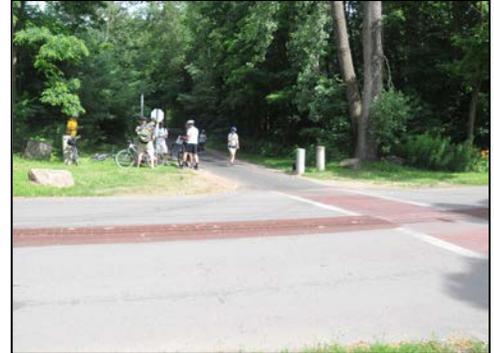
Starr Farm Park and Dog Park are nearby this path crossing but wayfinding should be improved

The short term improvements that are recommended at this location primarily include adding solid yellow centerline striping and new stop bars on the path, adding “stop ahead” markings on the path, and adding new W11-15 with W16-7P crossing signs on the street close to the crossing. The existing “stop” sign on the north bound approach should be relocated closer to the roadway. When this occurs it is also recommended that an R9-6 “yield to peds” sign should be added prior to the crossing to provide advanced warning that path users may need to yield to pedestrians on the sidewalk. Vegetation clearing is recommended at the four corners to the extent possible within the right-of-way to improve sight lines.

Long term improvements would include adding curbing along the north side of the road in either direction from the crossing to help define the road edge, thereby improving the traffic calming effect and protecting the path users. To conform with ADA requirements the pedestrian ramps should be outfitted with DWSs. This would likely be accomplished within the overall Bike Path Rehabilitation Project. All of these proposed improvements are shown in Figure 11.

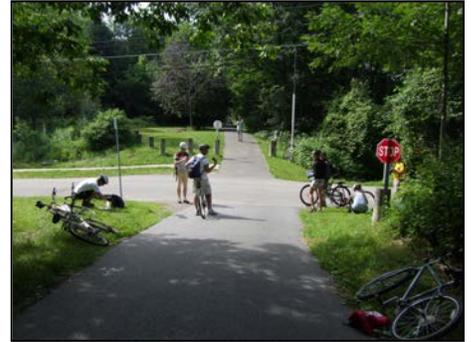
North Avenue Extension is a very low volume dead-end road that provides access to a number of lakeside cottages and campsites. The road takes a sharp bend to the north just west of the crossing. The path in this area is raised up above the surrounding ground on the former railroad embankment, but the path dips down as it crosses North Avenue Extension. This dip causes path users to accelerate toward the roadway crossing. Our observation is that many path users ignore the existing path stop signs so they can maintain their speed up the other side of the dip in the path. This is undesirable since sight lines are compromised on some of the corners by vegetation.

Existing path stop control and limited sight lines to the west at North Avenue Extension
