LAKE STREET
Burlington, Vermont

PEDESTRIAN, STREETSCAPE, AND STORMWATER
FEASIBILITY STUDY

June 30, 2020

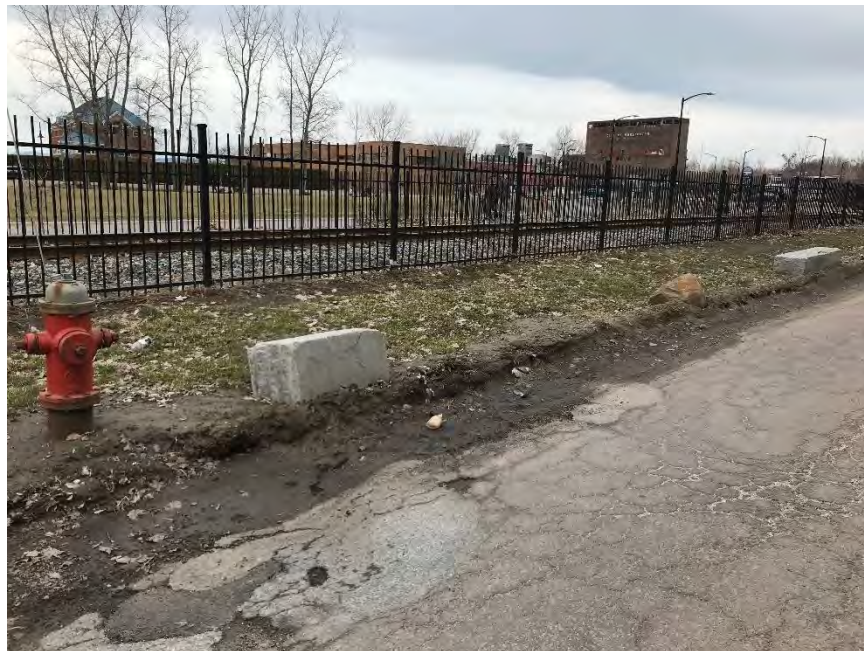
The project study area, identified in Figure 1 above, is located in Burlington, Vermont near the Waterfront Park. The study area is approximately 1,600' long and extends from the intersection with College Street to north of the intersection with Penny Lane. The pavement width is approximately 26' on the south end and 20' on the north end. There is a 5' wide concrete sidewalk with a 6-7' wide grass strip along the entire eastern side of the street. On-street parking exists from College Street to the point where the road narrows, just beyond the mid-block crossing to Waterfront Park. The road is in poor condition, especially along the shoulders on the west side as shown in Figure 2 below.

Figure 2: Weathering and alligator cracking along the shoulder on the west side of Lake Street.

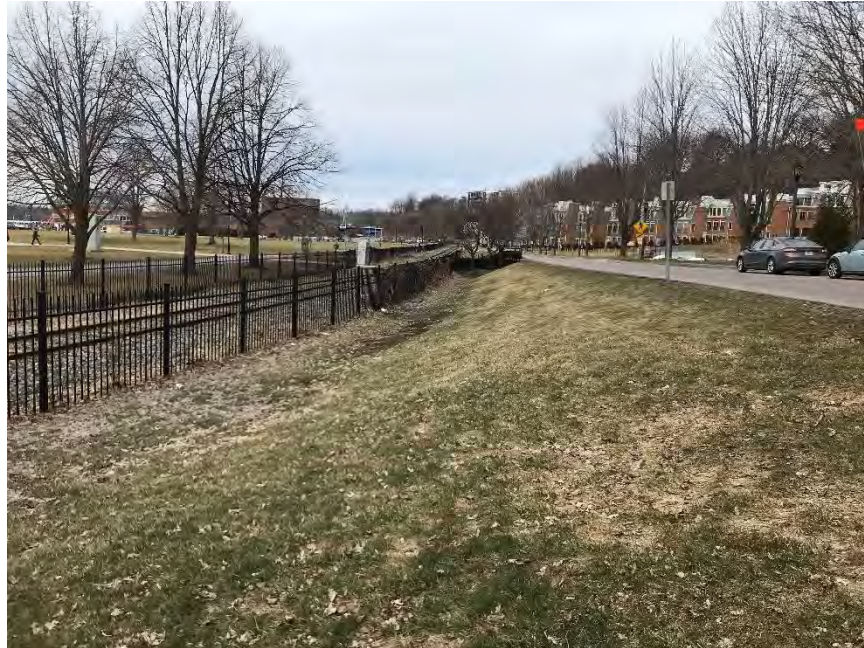
pedestrian crossing as shown in Figure 3 and Figure 4 below. These inlets discharge to a system within the Waterfront Park and then to Lake Champlain.

Figure 3: Southern swale looking north to drainage inlet.

The yard grates within the northern swale have been maintained and should be monitored to determine if this alone relieves flooding issues. In addition, this should be included in the Burlington inspection and maintenance program. If it is determined that maintenance alone does not relieve the flooding issues, it is recommended to install bigger structures such as beehive grates in the northern swale. Since the swale and drainage system do not extend along the entire length of Lake Street, a perimeter drain should be installed along the western edge of Lake Street from

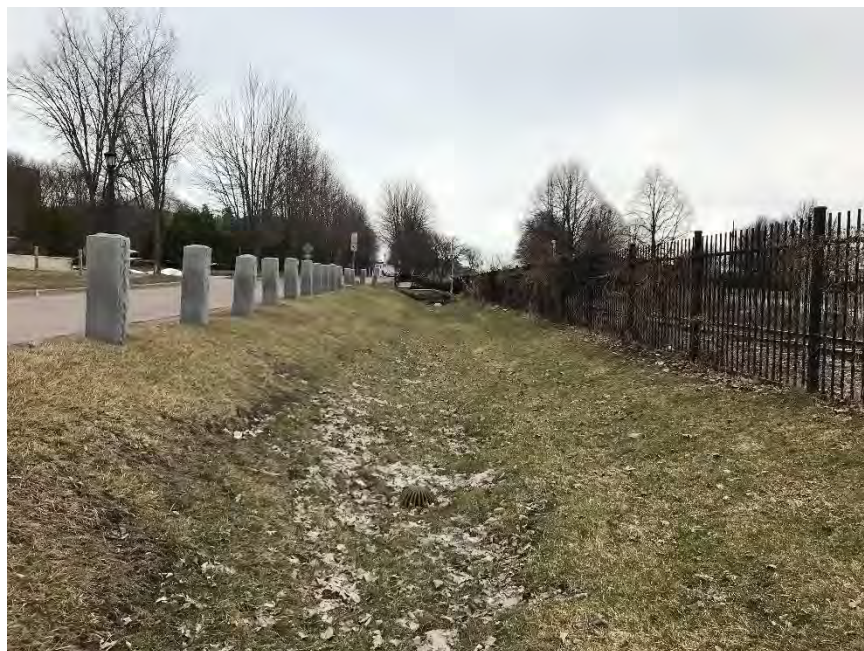
Figure 4: Northern swale looking south to drainage inlet.

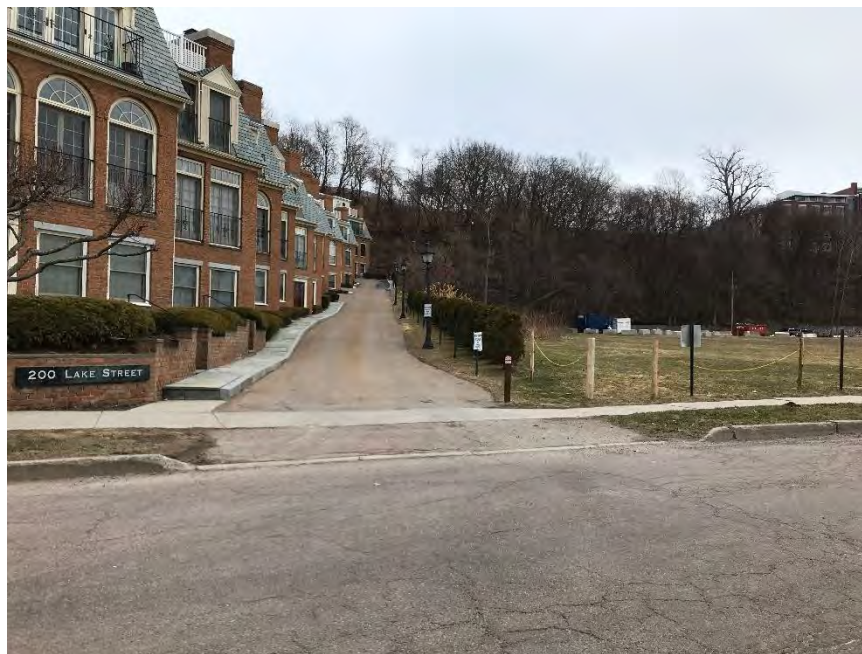
Just south of Penny Lane on the west side of the road, there is an area where frequent flooding occurs. The flooding is related to a system of pipes connected by 15" pipe risers with 15" diameter plastic grates within a drainage swale. During the initial site visit it was noted that these grates had not been maintained and were severely clogged with vegetation, soil, and debris. As seen in Figure 4, this swale has recently been maintained. Flooding issues should be reassessed during a rainfall event. This system of grates and this swale eventually discharges to a structure with a large 2.5' grate. Runoff contributing to this swale includes runoff from the 200 Lake Street Apartments, which was noted by the City to flow "like a river" down the main driveway and across Lake Street during heavy rainstorms. The main driveway for the 200 Lake Street Apartments is shown below in Figure 5.

Figure 5: The driveway for 200 Lake Street Apartments looking east.

The stormwater issues at the entryways to Foam Brewers and the 200 Lake Street Apartments need to be addressed. A proposed solution would be to work with the property owners to assist in developing stormwater detention and treatment practices to reduce flows and sediment loads from their property onto Lake Street. At the entryway to Foam Brewers, it is suggested that the parking lot is paved and drains to a low spot where that drainage area will be collected into a structure. For the 200 Lake Street Apartments, it is suggested that the driveway is regraded for sheet flow to the south and a detention practice be installed south of the driveway on the existing lawn.

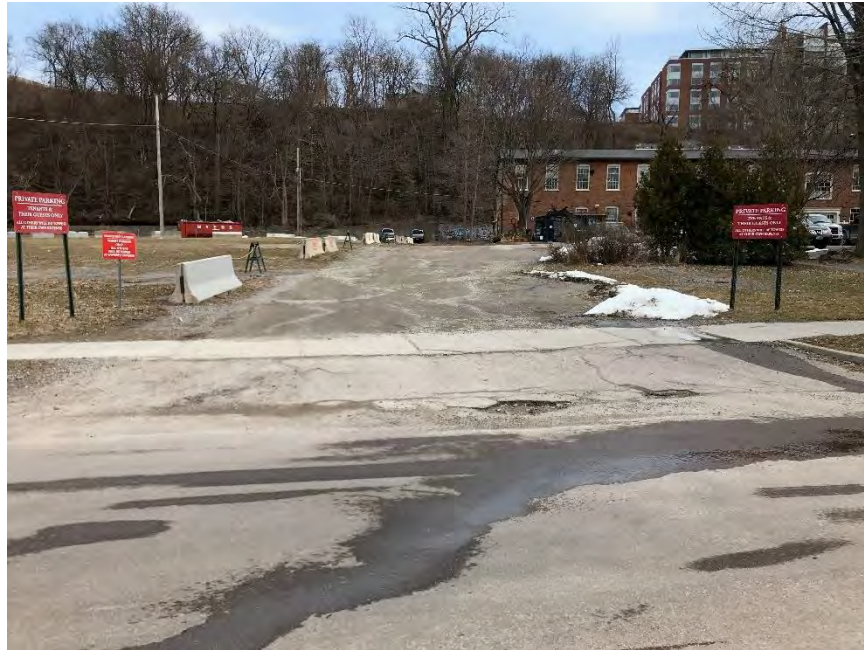
At the northerly entrance to the Foam Brewers gravel parking lot, large amounts of sediment have deposited on the sidewalk and drive apron. There are significant signs of erosion from the parking lot including gulying. Large amounts of runoff with substantial sediment loading during rainfall events had been noted by the City in this area. Small repairs have been completed to stabilize the swale where this runoff likely discharges. The sediment and erosion found at the entrance to the Foam Brewers parking lot is shown in Figure 6 on the following page.

Figure 6: Northerly entrance to the Foam Brewers gravel parking lot.

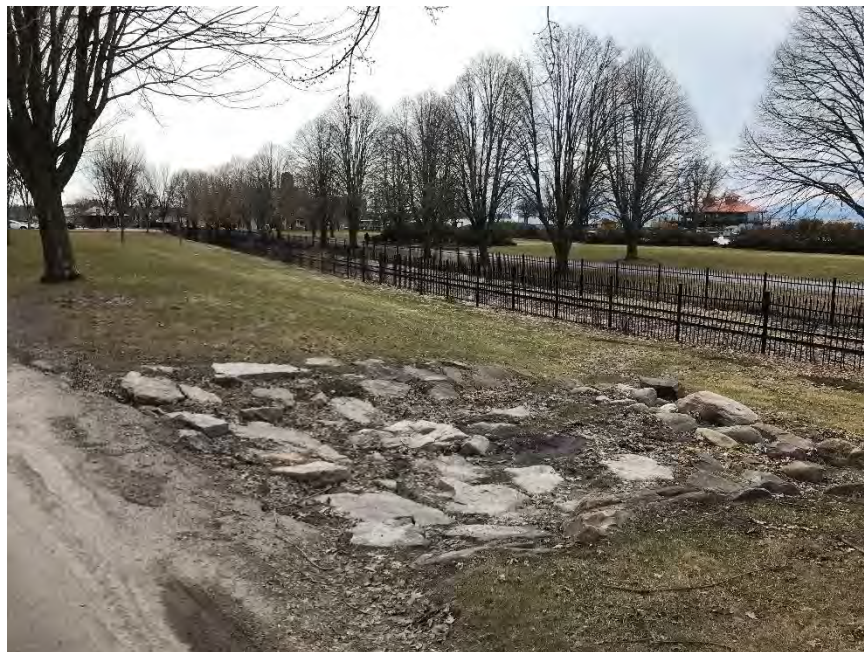
At the entrance to Merrill Lynch, there are signs of runoff from this site flowing across the street and into an area of large stone fill as shown in Figure 7 below. Large flows crossing Lake Street during rain events was noted by the City.

Figure 7: Large stone fill across the 102 Lake Street parking lot.

Stormwater runoff is high in sediment from the 102 Lake Street parking lot and discharges across the road from east to west. Large stone fill has been placed on the western end of Lake Street to slow down the stormwater runoff velocity before reaching the southern swale which drains north to the discharge area. This recommended improvement proposes two catch basins on the east side of the road which pipe into a bioretention system on the western edge of the road. This system would reduce the amount of sediment and stormwater runoff flowing across Lake Street and would treat the water quality volume for the area draining to the catch basins.

The northern catch basin would connect to the southern catch basin which would then connect under Lake Street into the bioretention system. Prior to laying down this pipe, it would need to be ensured that the existing underground utilities would not be impacted by the new stormwater pipe. Currently, underground electric, gas distribution, water main, sewer, and sewer pressurized main line run parallel to Lake Street. The stormwater pipe would enter the bottom of the pretreatment sediment forebay which would connect to the bioretention area via an earthen berm with 2:1 side slope. The depth of both the sediment forebay and the bioretention area would be 4' and 2', respectively. A hydraulic control structure would be installed on the northern end of the bioretention area to pipe above-design flows to the discharge area. In the event installing structures and pipes is not feasible, alternatively, the stormwater runoff could sheet flow across Lake Street as it currently does and would collect into the bioretention system through a pretreatment grass filter. However, the structures and pipes are important to prevent higher flows of runoff from weathering the pavement on Lake Street.

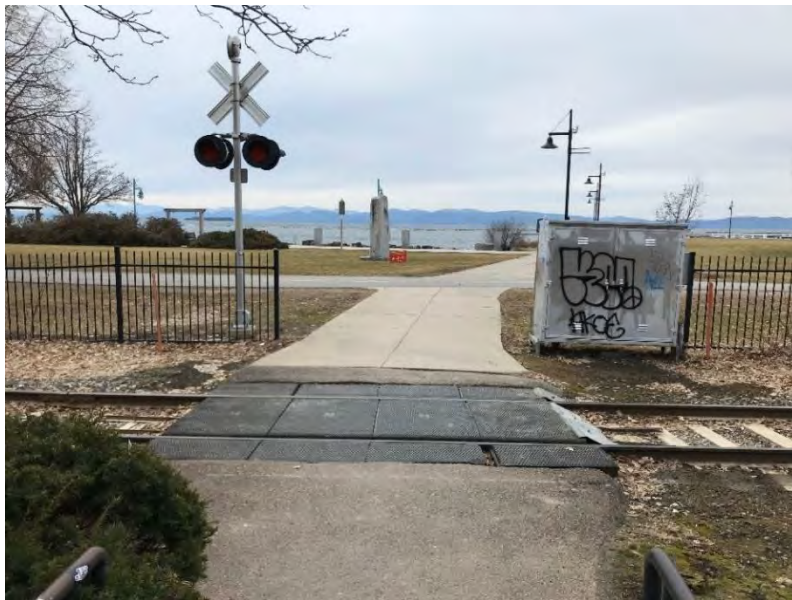
Along the project corridor there are two mid-block pedestrian crossings. Both crosswalks are painted brick crossings that have seen considerable weathering. One crossing leads to the Waterfront Park and the other to the City of Burlington parking area. There is limited site distance for both mid-block crossings due to the close vicinity of on-street parking. The existing mid-block railroad crossing to the Waterfront Park also does not have the required detectable warning surfaces as shown in Figure 8 below. At the intersection with Penny Lane and Depot Street, there is no formal ADA compliant pedestrian crossing to get people from Lake Street over the railroad tracks and to the Waterfront North as shown in Figure 9.

Figure 8: Mid-block pedestrian crossing over railroad to Waterfront Park.

Great Street Initiative. The current printed bricks with red paint should be replaced. The preferred style of crosswalk is the Conventional Continental Crosswalk style pictured in Figure 17.

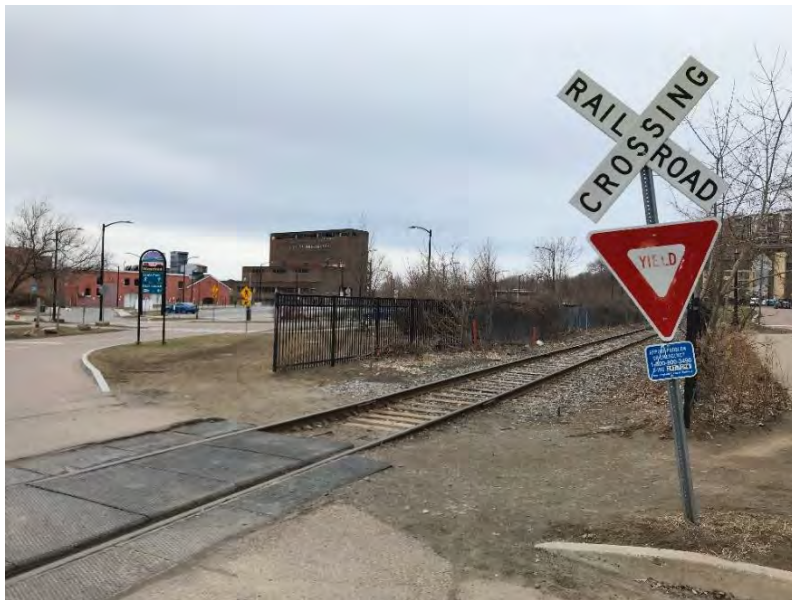
Figure 9: Railroad crossing on Penny Lane with no formal pedestrian crossing.

The intersection of Penny Lane, Depot Street, and Lake Street at the northern end of the project area presents a challenge for both pedestrians and cyclists to cross the road and railroad tracks safely to access the Island Line Trail and Waterfront Park. The first alternative to addressing this issue uses line striping and signage while the second alternative proposes a shared use path on top of the railroad tracks which connects to the existing infrastructure along with a bike path down Depot Street using minor curb work to improve safety and be ADA compliant.

For the Line Striping alternative, Penny Lane is converted into two 10' lanes with a 5' shoulder on the northern edge and additional stop measures are added on the eastern edge of Lake Street for vehicles and cyclists riding down Depot Street, shown below in . While not a formal railroad crossing, this alternative address pedestrian and cyclist safety by giving pedestrians a space to

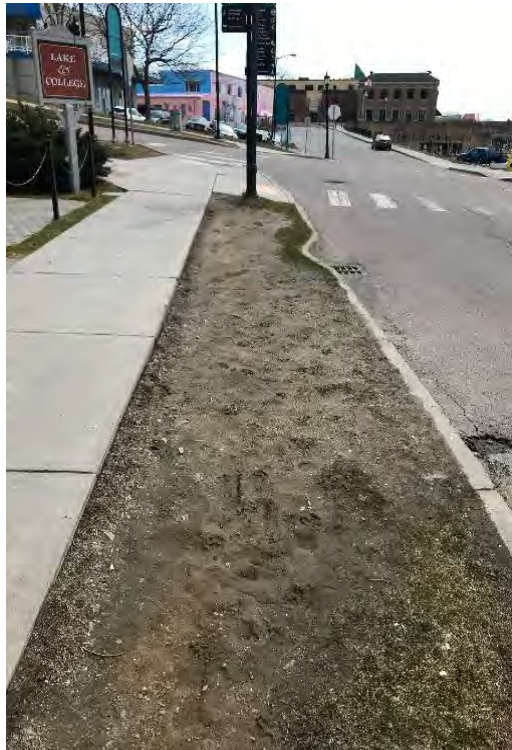
Several grassed areas were noted by the City as “trampled down.” The main area of concern is in front of the Skinny Pancake between the sidewalk and Lake Street. There is no grass growth in this area as shown in Figure 10, and it was noted that pedestrians either walk or stand in this area.

Figure 10: Trampled down area in front of Skinny Pancake on Lake Street.

The 6-7' wide grass strip on the eastern edge of Lake Street from Skinny Pancake to the entrance of the 60 Lake Street building is significantly trampled down with no grass growth. This recommended improvement proposes the use of permeable pavers along this grass strip. Permeable brick pavers would make the streetscape of Lake Street more aesthetically pleasing and allow pedestrians to walk or stand on them without drastically eroding the surface over time. In addition, permeable pavers will infiltrate stormwater runoff helping recharge groundwater and reduce flow to the existing drainage network.

The width of the 3" interlocking permeable pavers would be 5' and they would be placed directly adjacent to the existing 5' wide sidewalk. The pavers must adhere to the Great Street standards by being red clay or gray concrete. Notably, the red clay is found to have higher durability in environments with high salting during the winter. The cross-section layering of the Permeable pavers would include interlocking concrete pavers, a sand settling bed, compacted subgrade, and a base course from top to bottom. The three existing maple trees would remain with tree grates added for protection. There is also one existing catch basin on the southern end which would remain. This improvement is depicted in below in Figure 11: *Proposed hardscaping with permeable pavers along Lake Street.*, with additional details provided in Figure 1 of Appendix E.
