Burlington Bike Path Intersections Scoping Study

In the City of Burlington, Vermont

January 20, 2014

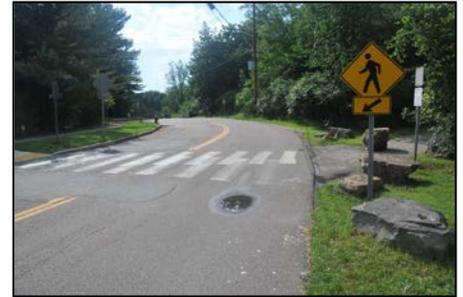
Austin Drive bike path connection showing unmarked boulder and limited sight distance

Long term improvements can also be made to this intersection to improve accessibility for all users. The path should be realigned to the west slightly so as to create a perpendicular crossing as opposed to the existing skewed alignment which encourages high speed cyclists to enter the path dangerously. A curb can be placed on the north east corner of the crossing to enforce this. In

addition, to replace the hazardous boulder in the middle of the path, a splitter island should be designed to prevent motor vehicles from entering the park by the bike path and to also slow cyclist speeds as they enter the intersection of Austin Drive. The splitter island should include a reflectorized removable bollard and flush imprinted pavement as a base. During large scale athletic events, such as the marathon, when many users need to share the path it will be important not to have an obstruction constricting the path width. The existing boulders in the area can be utilized on the outside of the path to define the entrance if desired. Detectable warning surfaces (DWS) should also be added to the crossing in accordance with ADA guidelines similarly to all of the intersections present herein. All of these proposed improvements can be seen on Figure 2 on the following page.

- RECONFIGURE PATH ENTRANCE TO BE MORE PERPENDICULAR
- SHIFT CROSSWALK
- ADD DETECTABLE WARNING SURFACE (DWS)
- USE CURB INSTEAD OF BOULDERS TO DEFINE TRAIL ENTRANCE
- CONSTRUCT SPLITTER ISLAND TO REPLACE BOULDER IN PATH WITH REMOVABLE BOLLARD TO RESTRICT MOTOR VEHICLES. DEFINE SPLITTER WITH FLUSH IMPRINTED PAVEMENT
- ADD PAINTED DIRECTIONAL ARROWS ON PATH

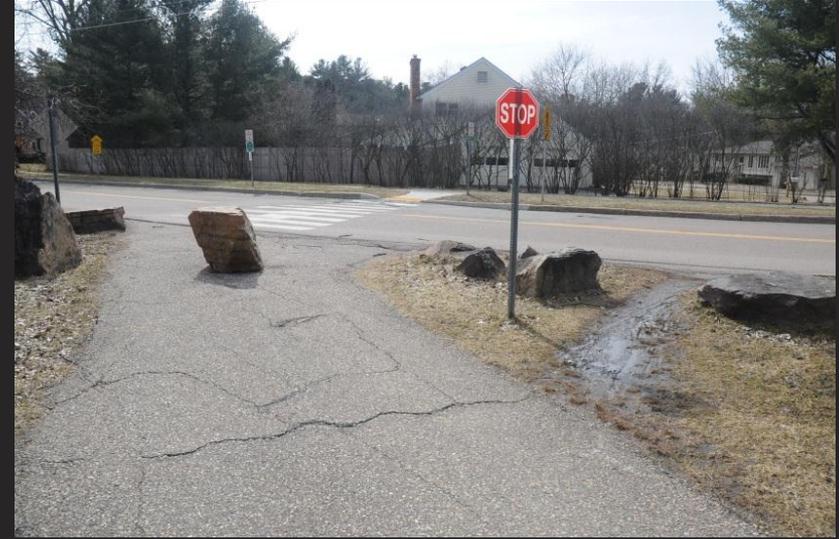
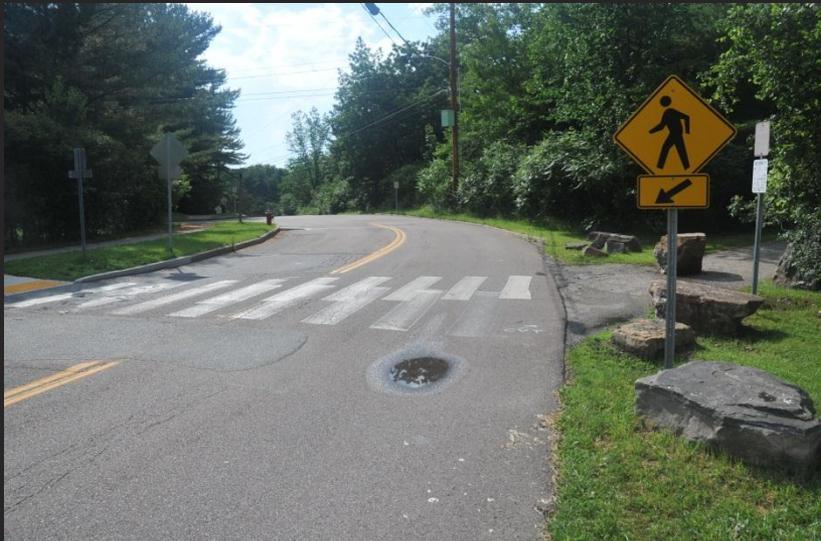
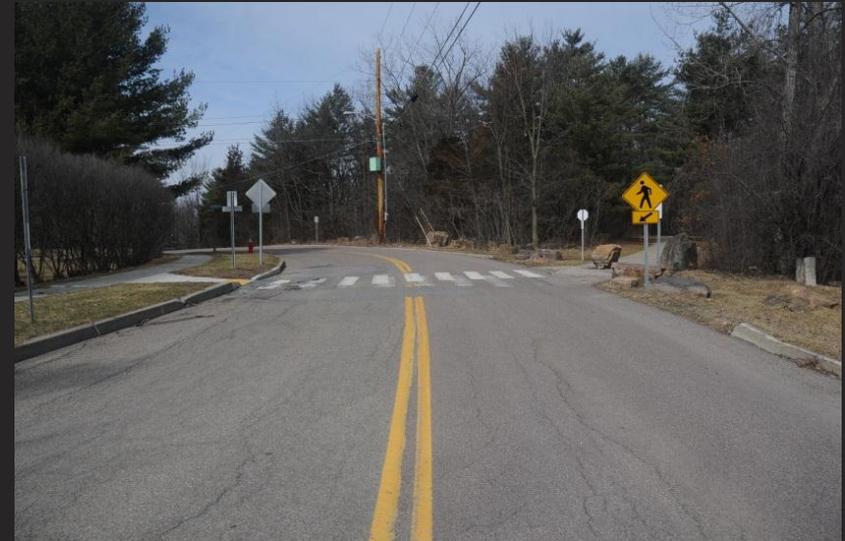
Austin Drive

- Boulders
- Bike Cut Through
- Limited Wayfinding
- Skewed Alignment

- Add Path Markings
- Update Signage
- Add Wayfinding
- Realign Path and Shift Crosswalk
- Add Bike Path Splitter Island in Place of Boulder
- Add Curb to Define Path Entrance

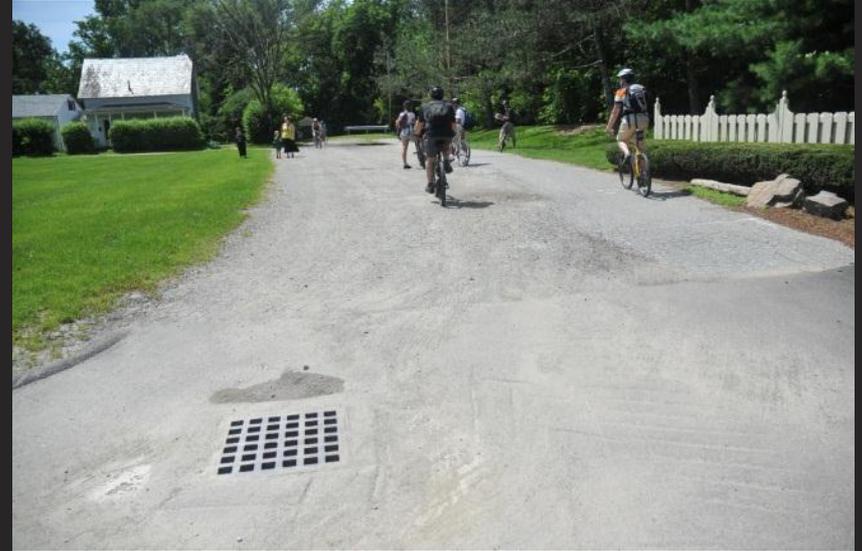
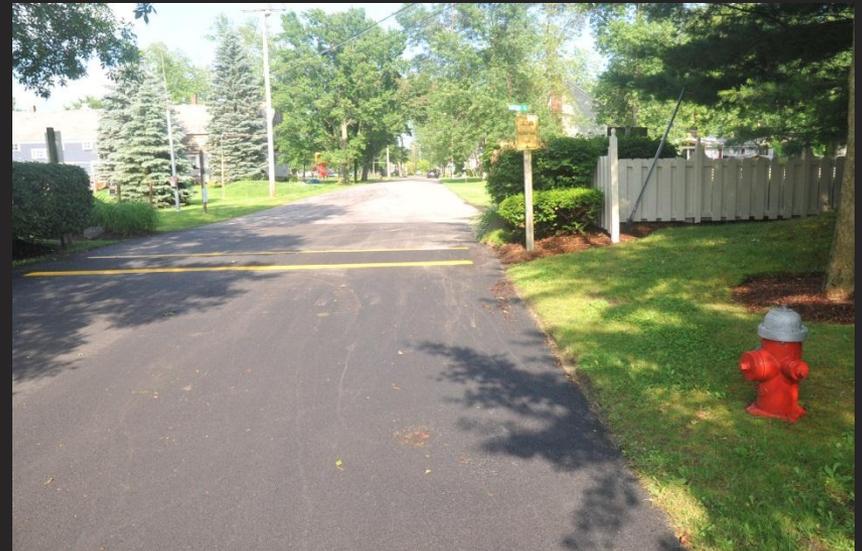
Harrison Avenue (West)

- Visibility from Harbor Watch Property
- Limited Signage
- Limited Wayfinding
- Proctor Place/Cut Through

- Replace High Corner Shrub with Low Lying Vegetation to Improve Corner Sight Lines
- Add Path Markings
- Pave Entrance to Proctor Place to help Define Path / Road Boundary

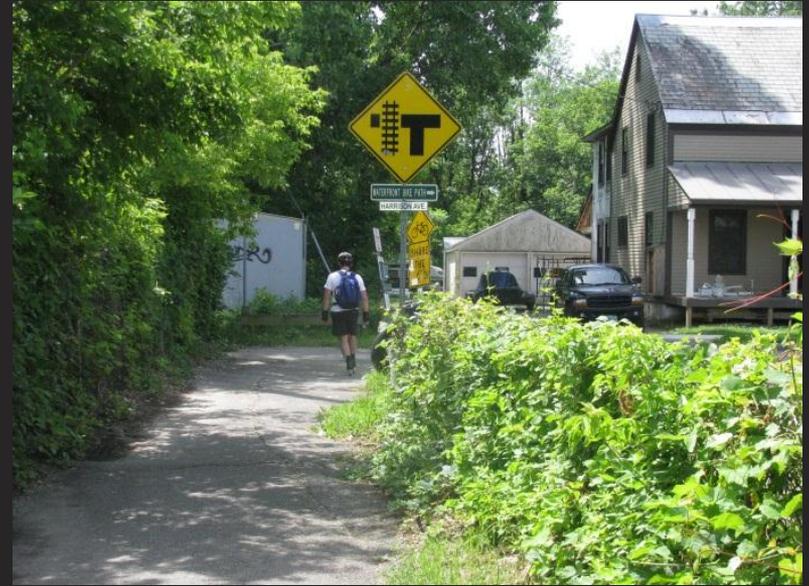
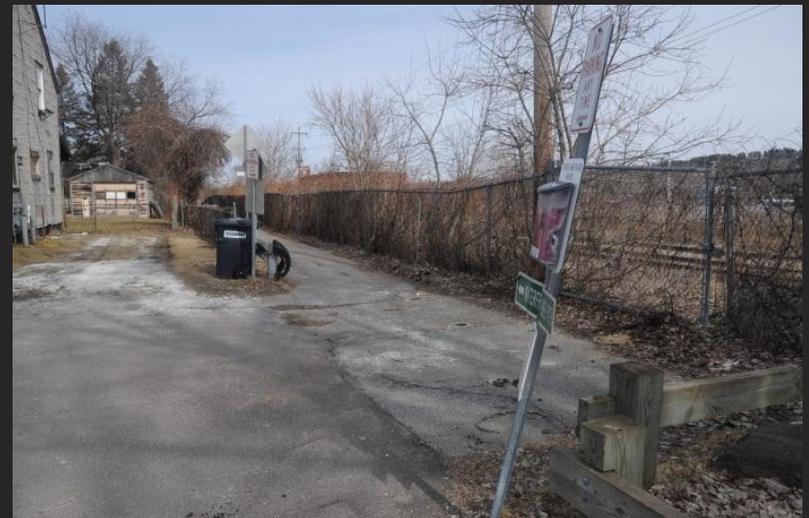
Harrison Avenue (East)

- Limited Signage
- Limited Paint Markings
- Minimal Sight Distance
- Path Alignment

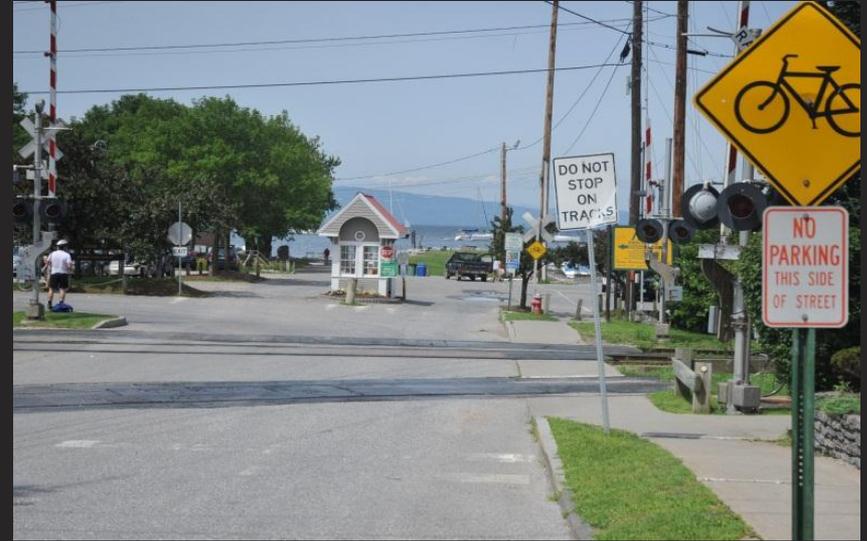
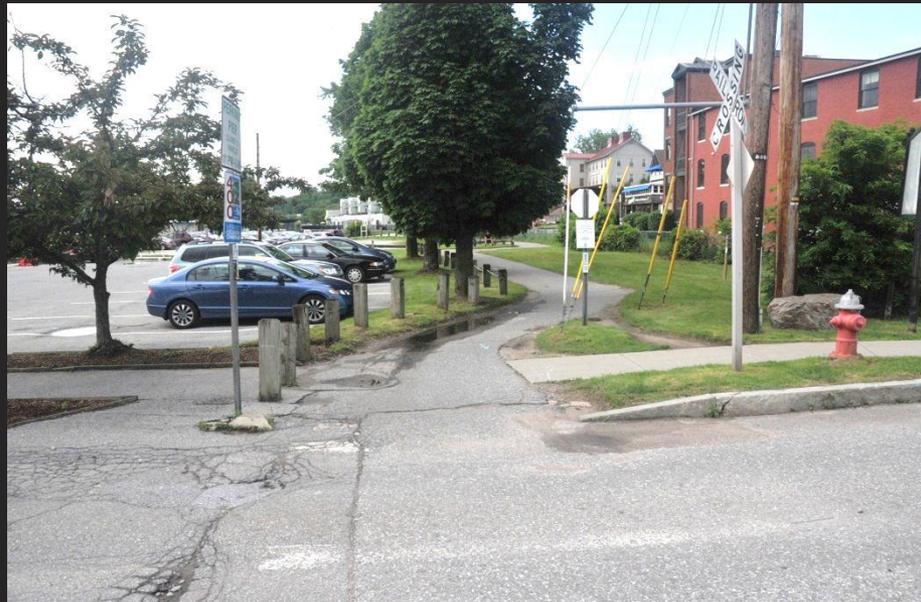
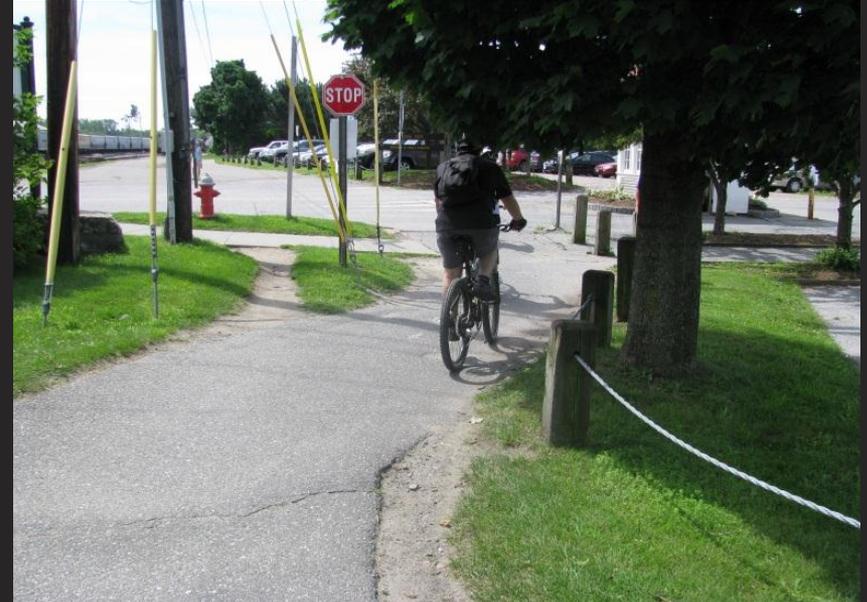
Maple Street

- Utility Conflicts
- Sight Lines
- Bike Cut Through

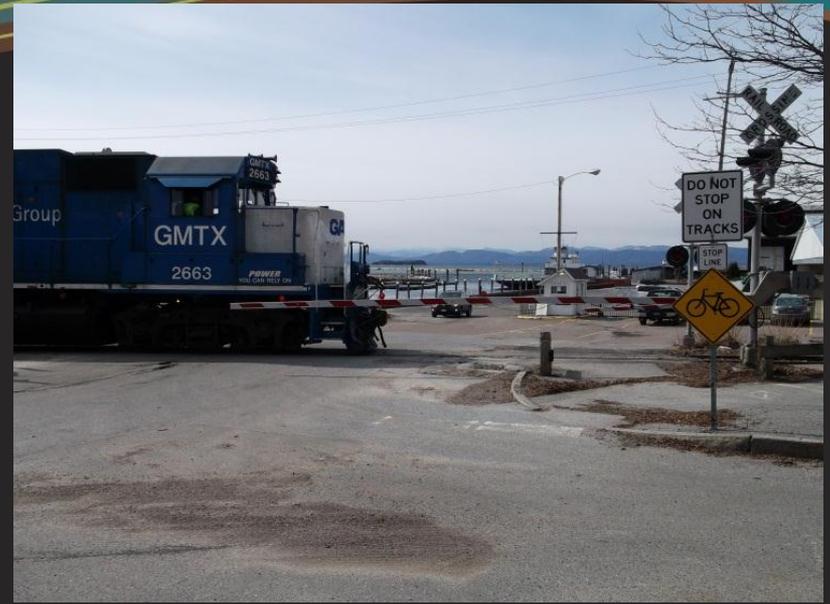
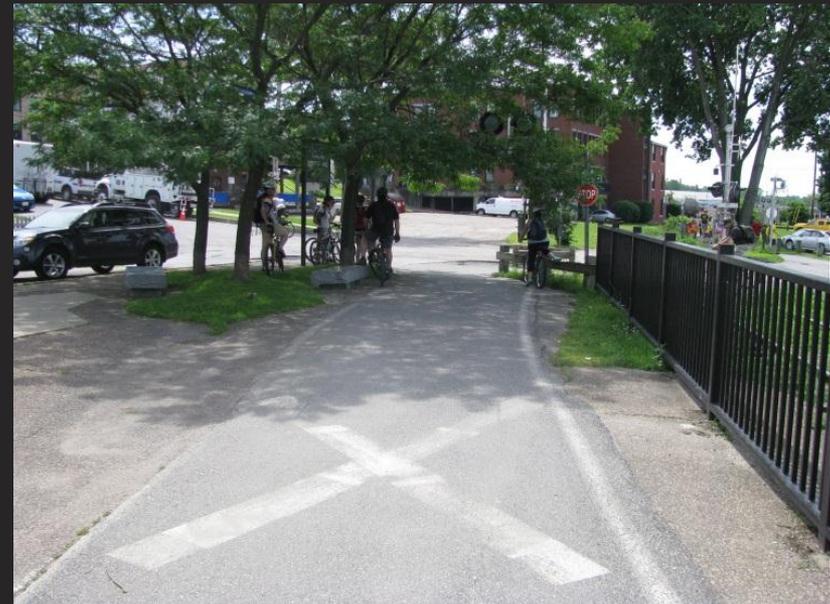
King Street

- Alignment
- RR Track Crossing
- Limited Wayfinding/Signage
- Lack of Travel Path Definition

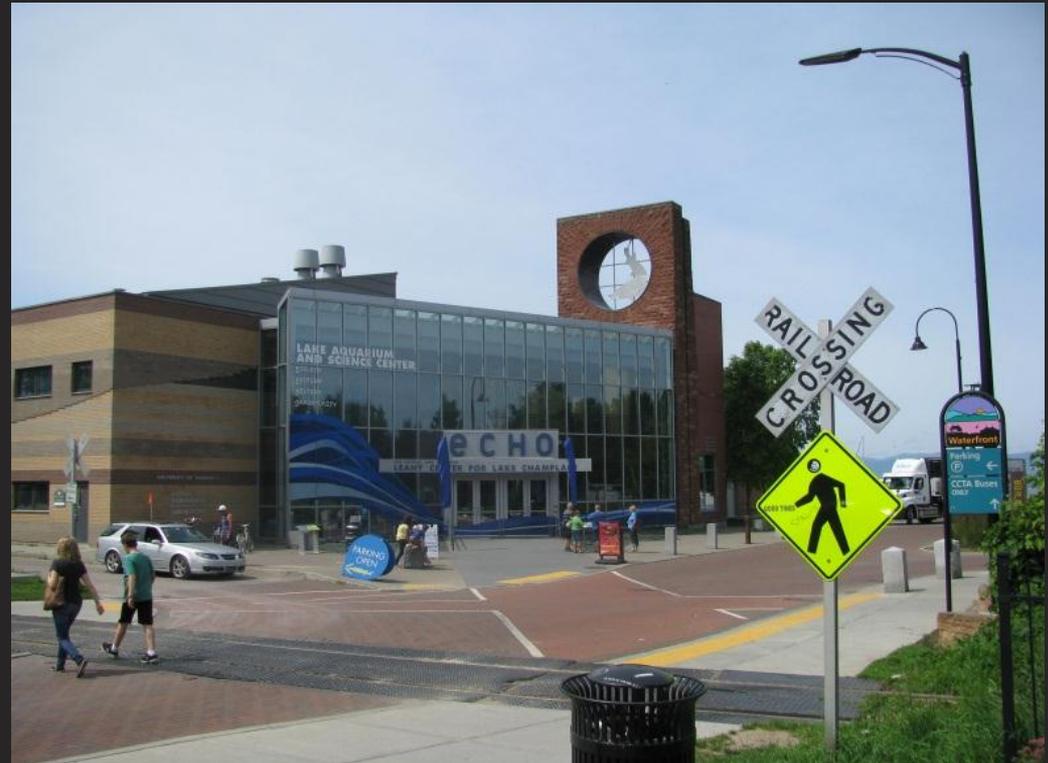
College Street

Concerns:

- Bike / Ped Conflicts
- Jogged Alignment
- RR Track Crossing
- Lack of Clear Definition
- Ice Cream Stand

Solutions:

- Enhance Path Markings
- Update Signs
- Pedestrian Railing to Separate Ice Cream Stand from Path

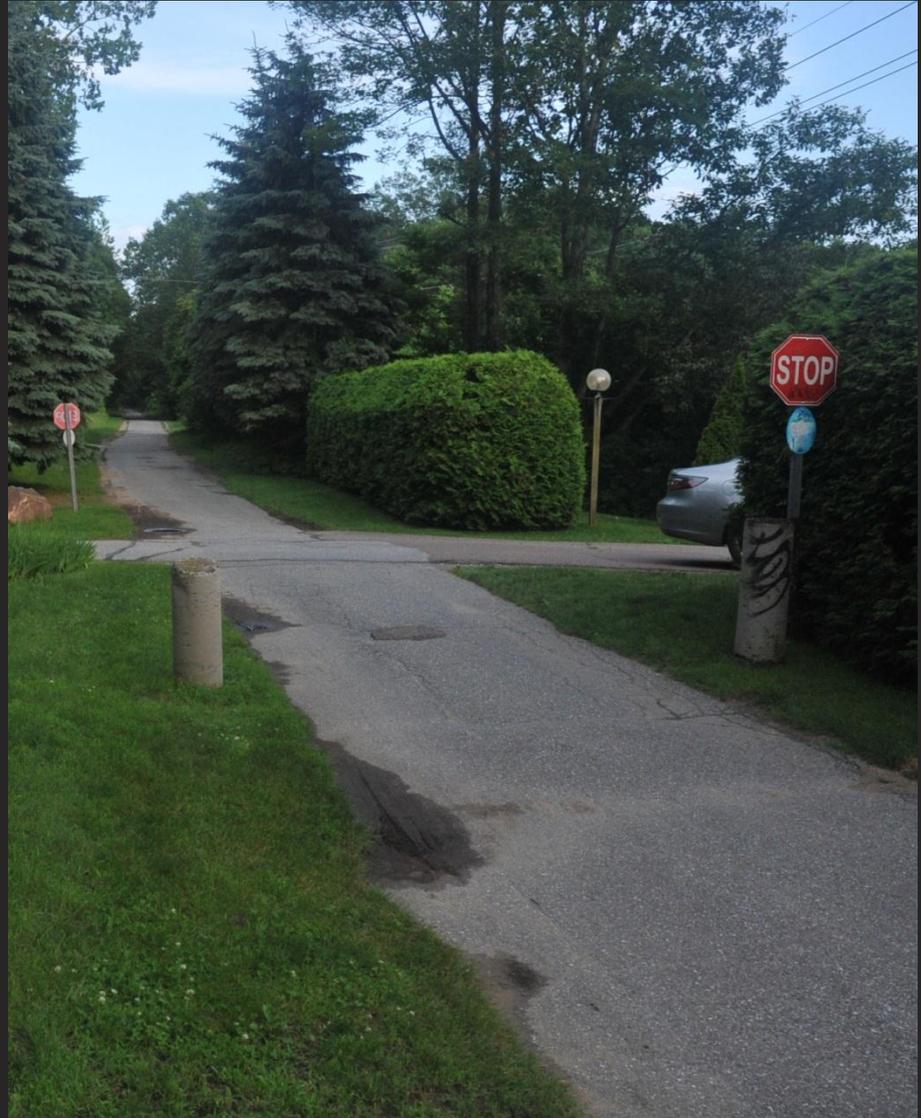
Little Eagle Bay

Concerns:

- Hedges Limit Visibility
- Extremely Low Car Volume Leads to Cyclist Complacency

Solutions:

- Trim Trees
- Add/Update Signs
- Add Convex Safety Mirror
- Shift Path to East

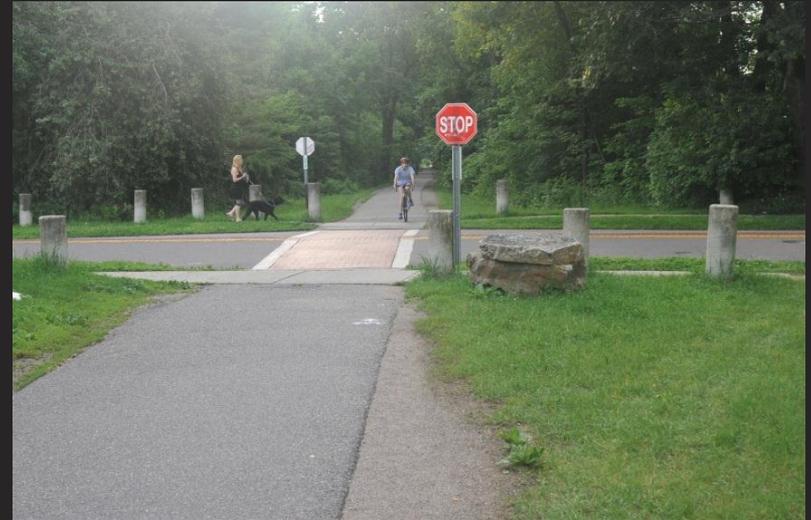
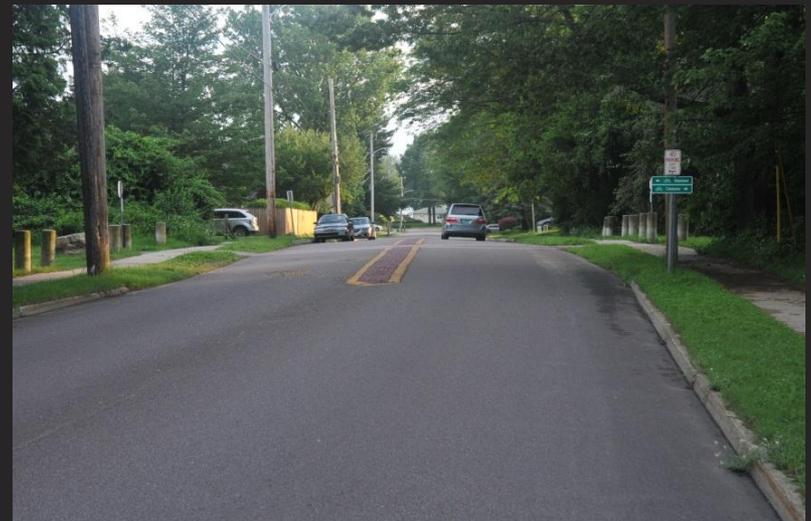
Shore Road

Concerns:

- Constrained Sight Lines at Crossing
- Lacking Crossing Signs

Solutions:

- Trim Trees
- Update Signs
- Update Path Markings
- Consider:
 - Bump Out for Additional Sight Distance and Traffic Calming
 - RRFB's or "Cross Alert" Flashers

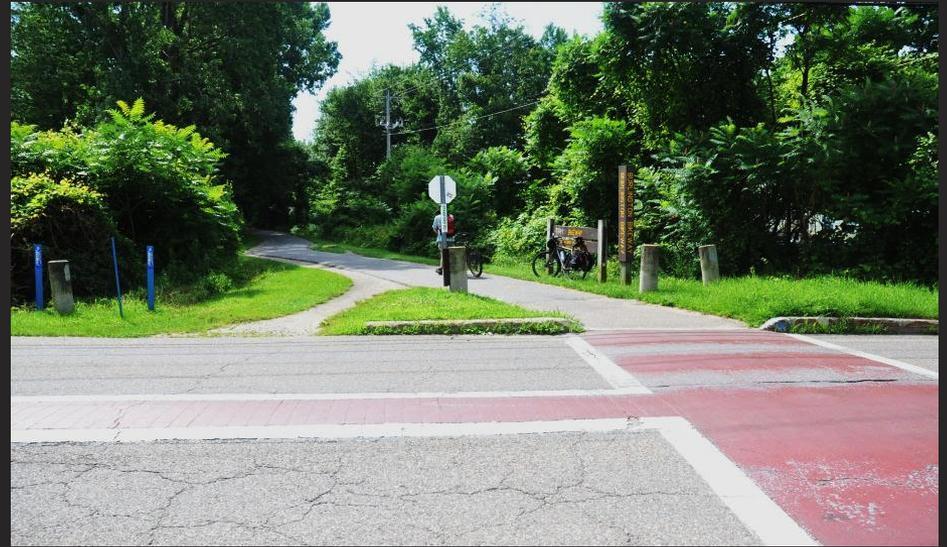
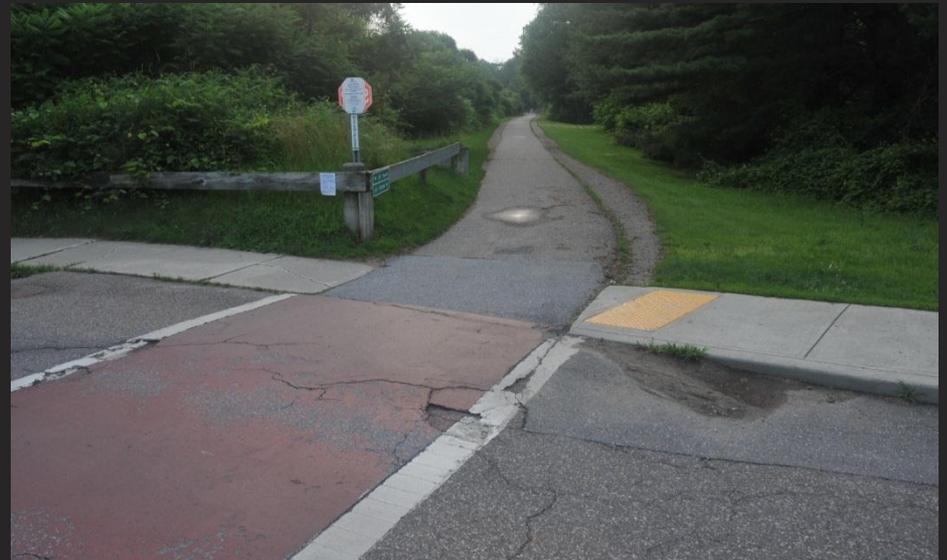
Staniford Road

Concerns:

- Bike Cut Through
- Constrained Sight Distances
- Lacking Crossing Signs

Solutions:

- Update Signs
- Add Pavement Markings
- Consider:
 - Bump Out on North Side
 - RRFB's or "Cross Alert" Flashers

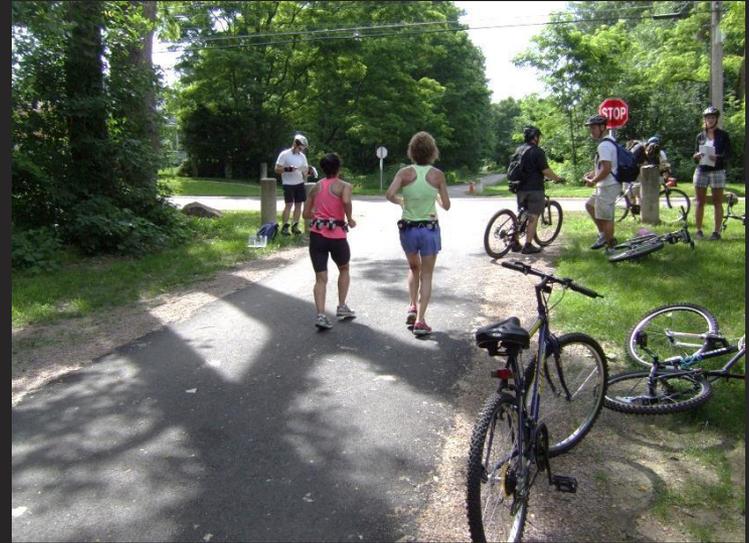
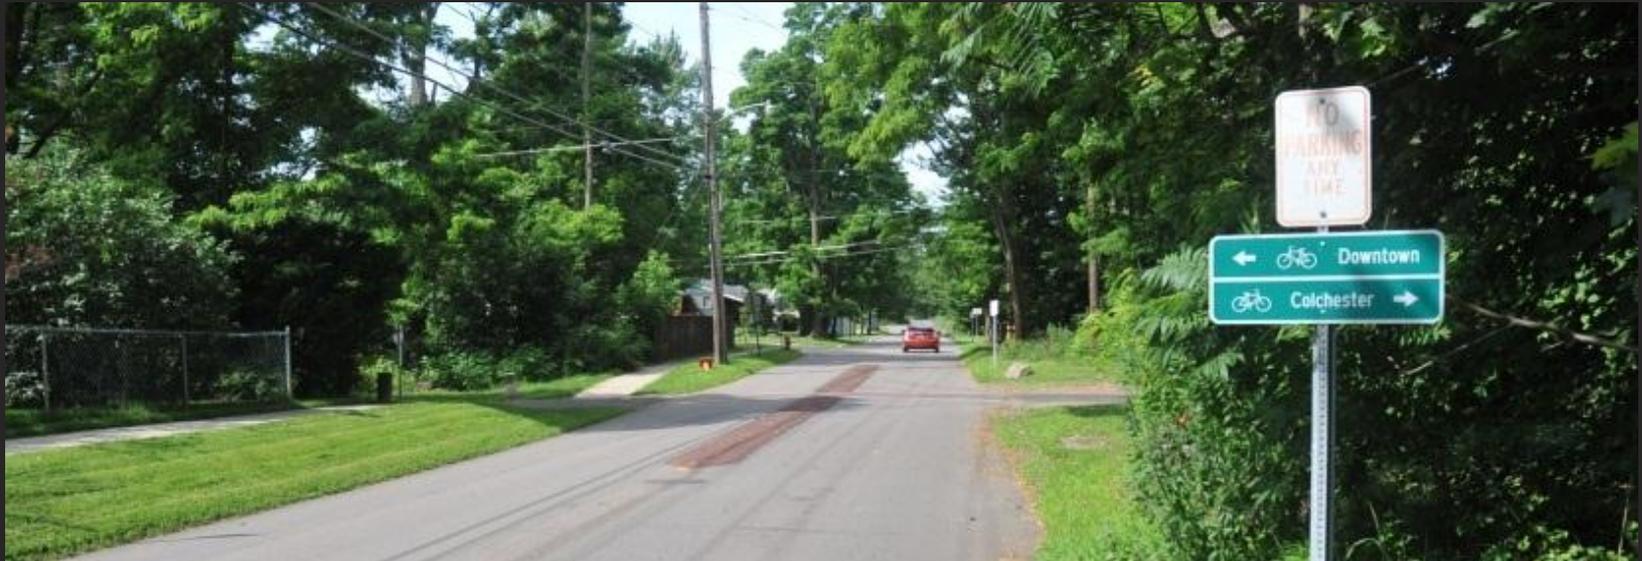
Starr Farm Road

Concerns:

- Limited Sight Distances
- Lacking Crossing Signs

Solutions:

- Update Signs
- Trim Trees
- Update Path Markings
- Add Curb to North Side of Road
- Consider RRFB's and "Cross Alert Flashers"

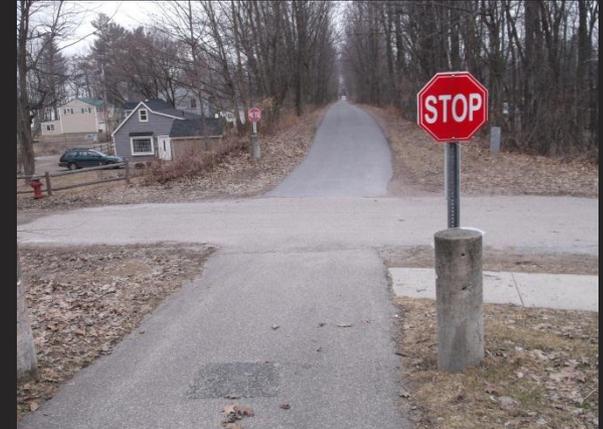
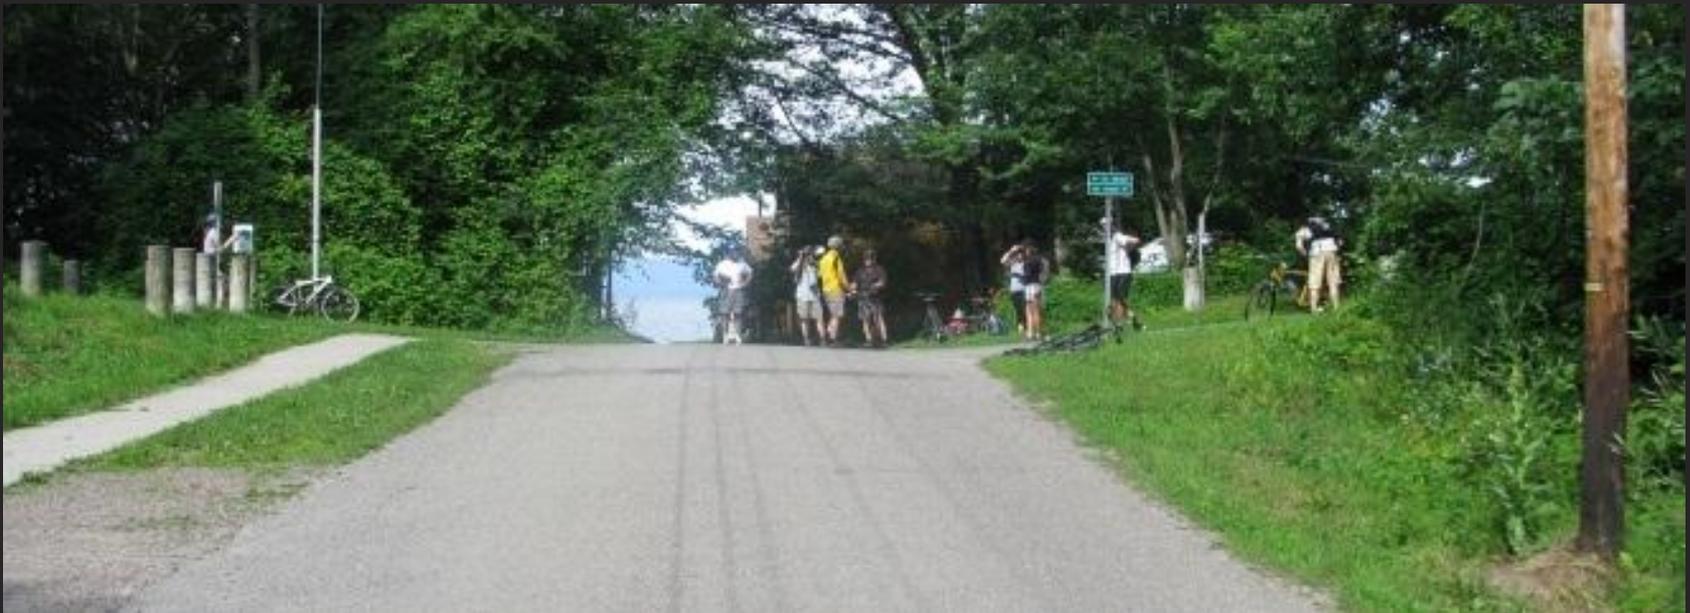
North Avenue Extension

Concerns:

- Downhill Path Grades
- Lack of Markings
- Lack of Wayfinding Signs

Solutions:

- Add Pavement Markings
- Add Detectable Warnings
- Update Signs
- Consider North Ave. “Stop” Control
