Memorial Auditorium

Burlington, Vermont

Historic Preservation Report

June 14, 1996

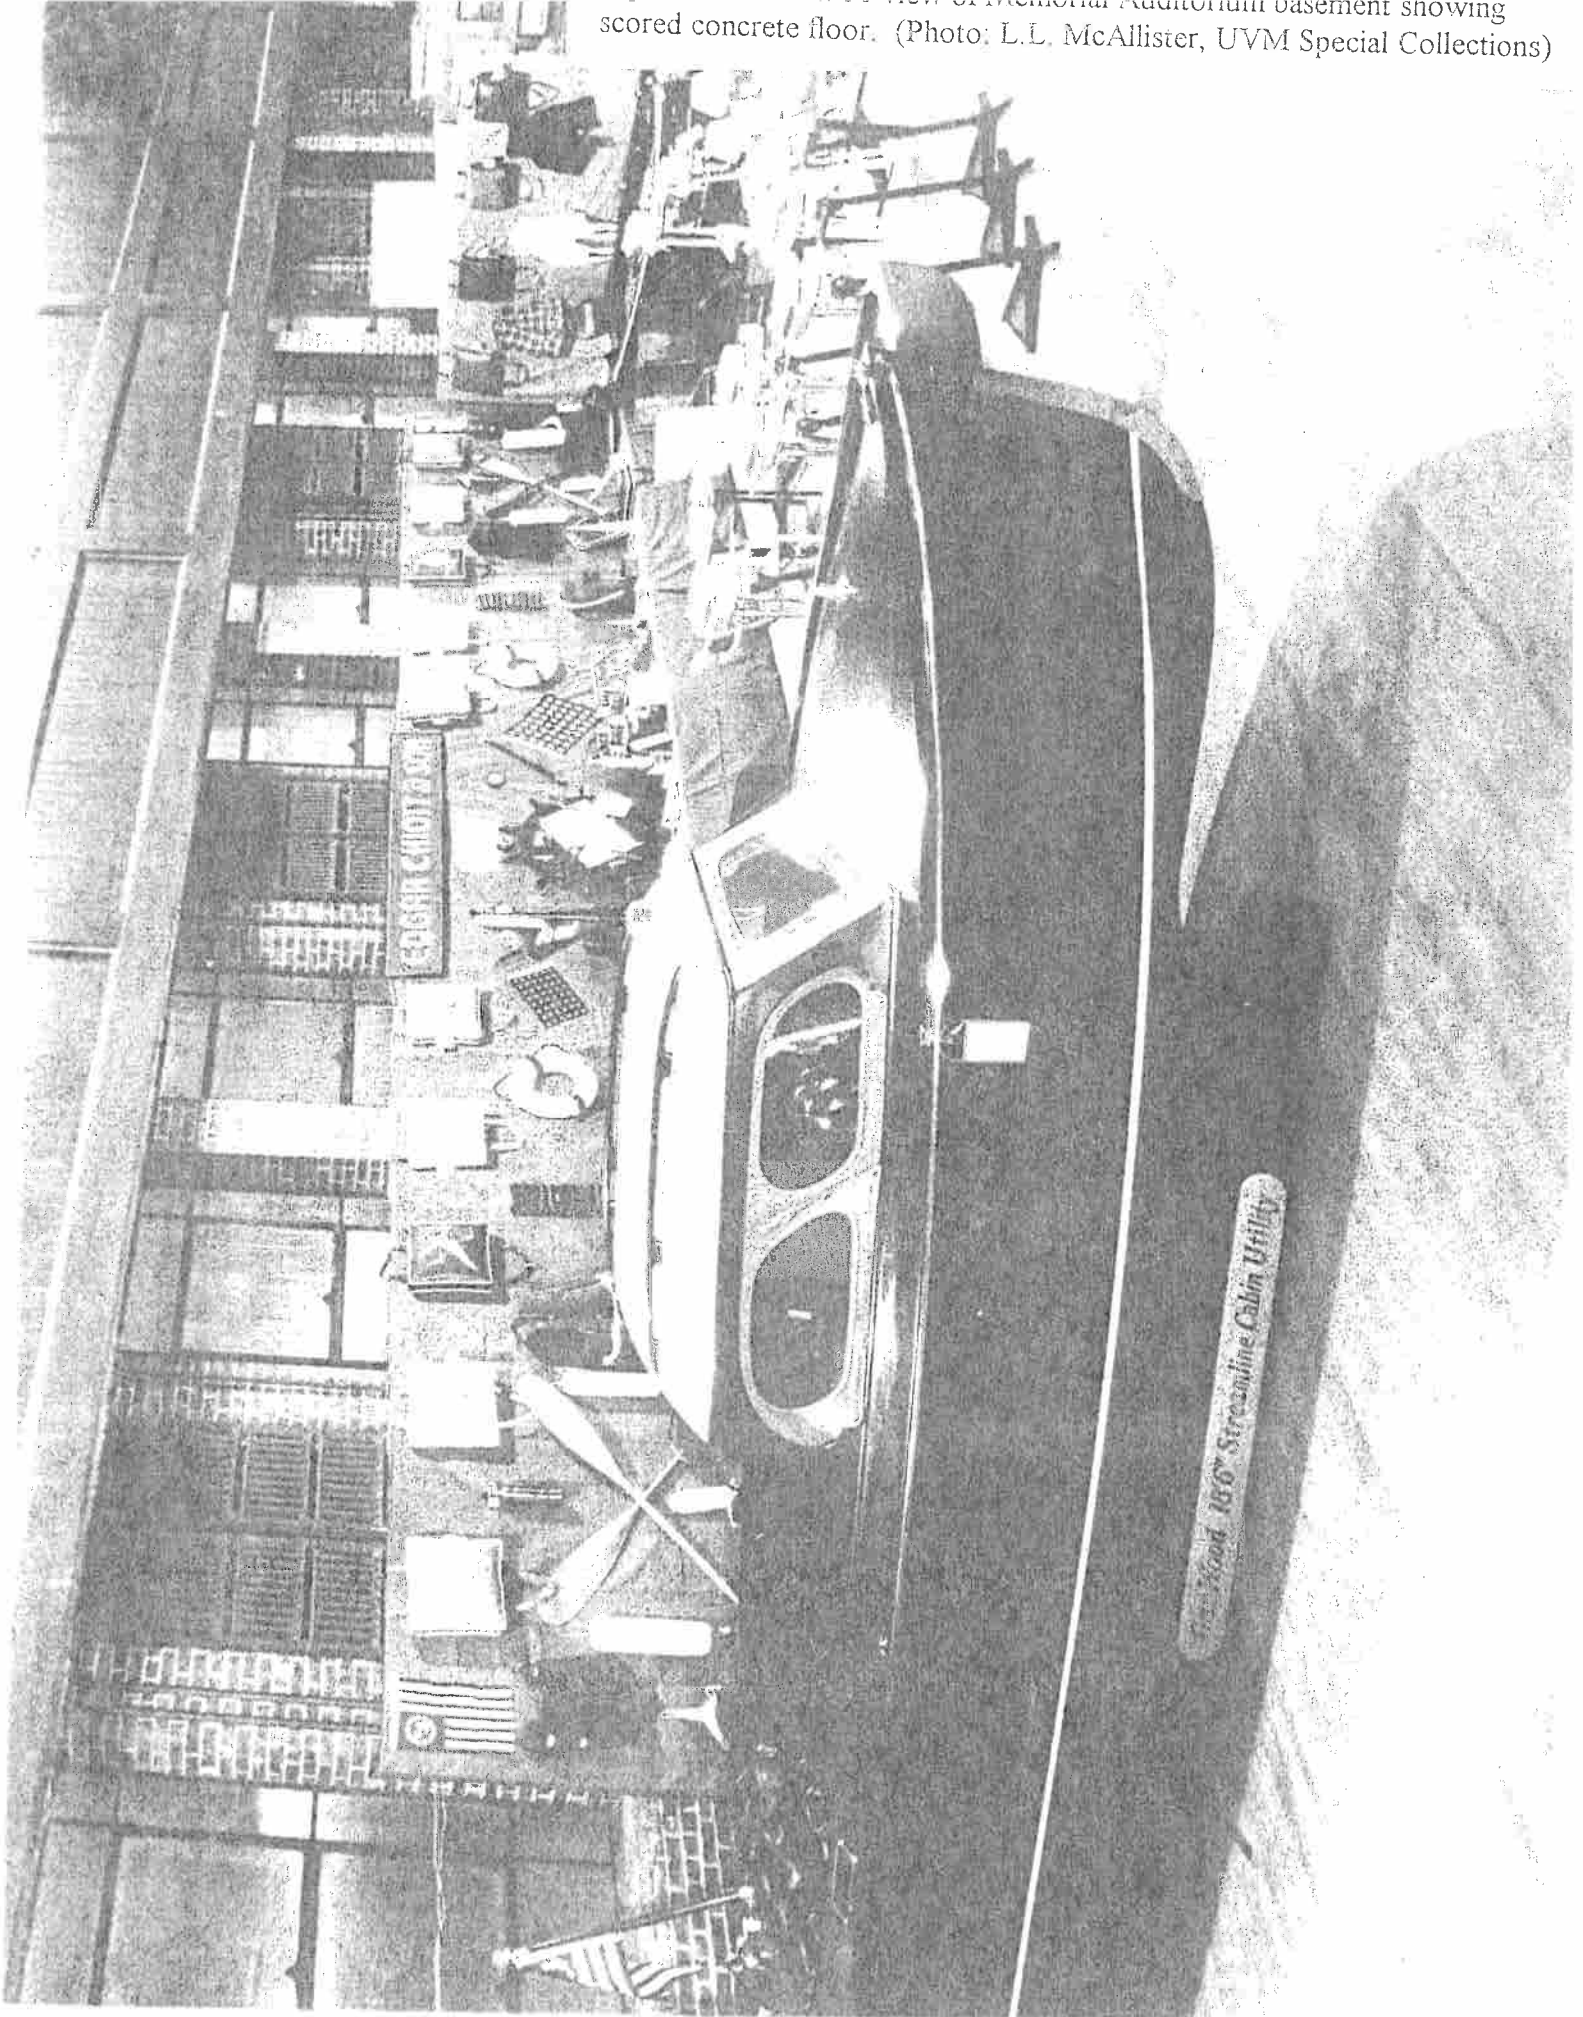
Interior changes to the building include the addition of a tile floor in the basement over an original scored concrete surface, the replacement of an original stage curtain, and the removal of the folding chairs on the floor of the auditorium.

View of Memorial Auditorium basement showing scored concrete floor. (Photo: L.L. McAllister, UVM Special Collections)

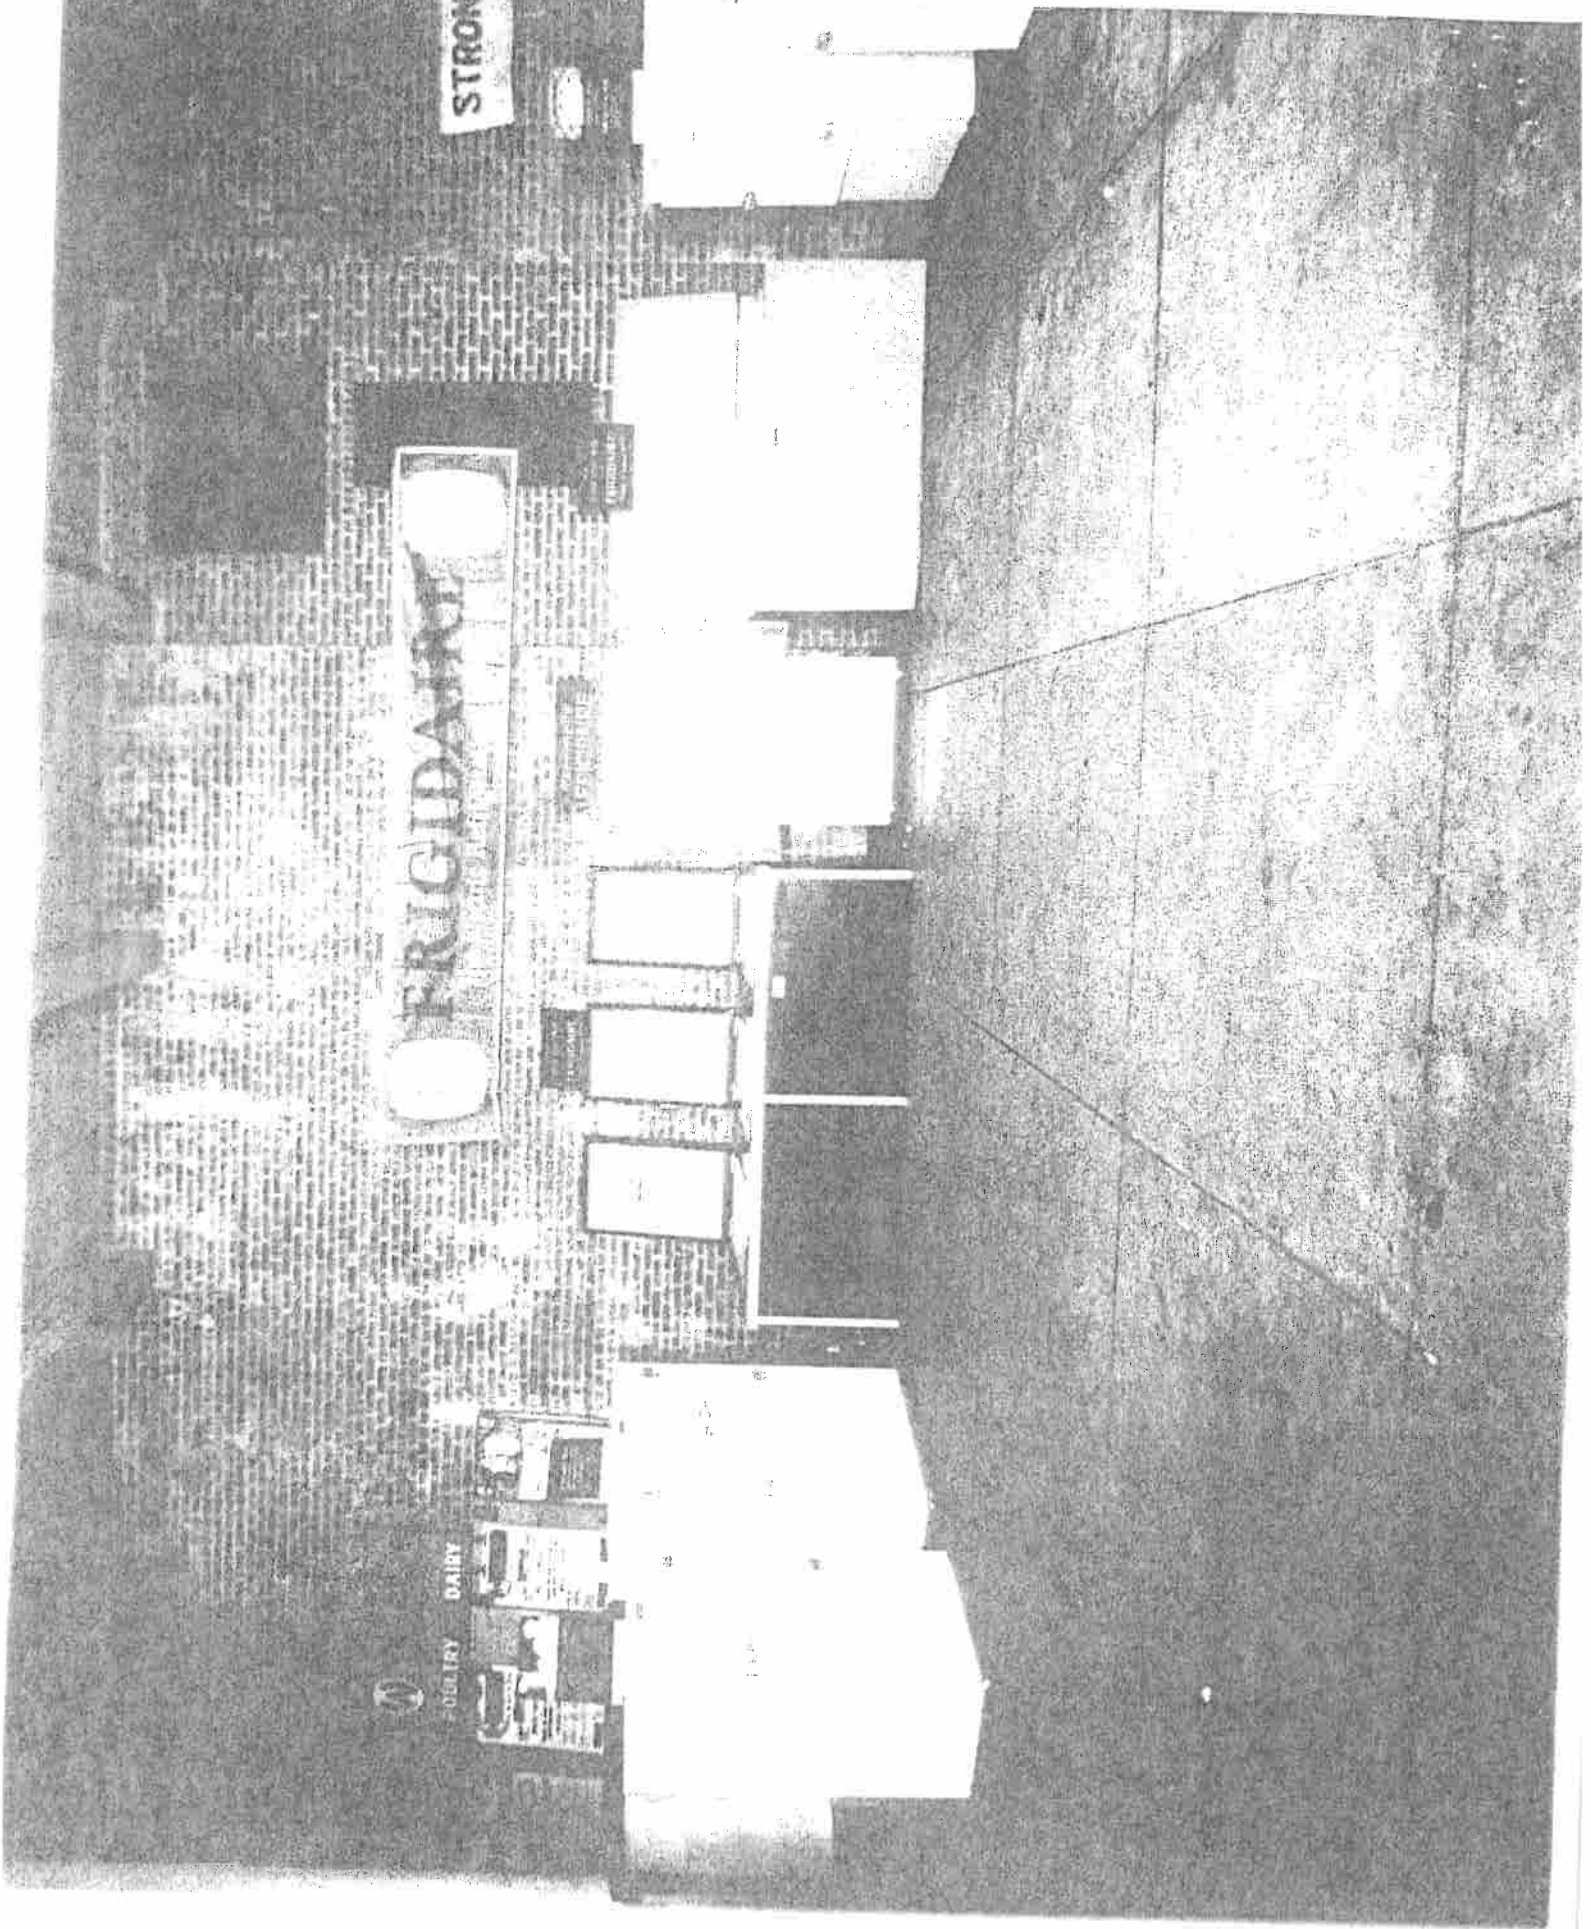
Many of the original metal windows are located at the corner towers of the building. These narrow, 'awning' style windows have opaque glass and two or three horizontal muntins. All of the windows on the building feature flat arches and concrete sills.

Figure 1. Circa 1930 view of auditorium. Note original steel tawning windows that were in the auditorium and basement. (Photo: L.L. McAllister, UVM Special Collections)

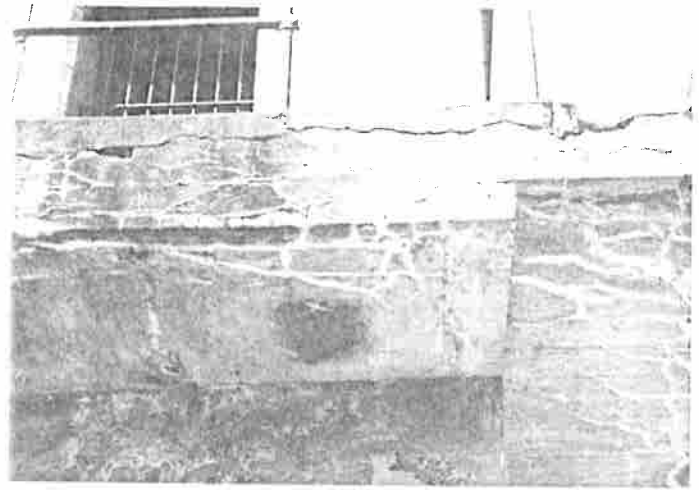
Fig. 7. Battery Commander's Station, Ft. Washington, Maryland (1904). This reinforced concrete tower with a cantilevered balcony is showing serious deterioration. Water has penetrated the slab, causing freeze-thaw spalling around the posts and corrosion of the reinforcing bars. This internal corrosion is causing expansion inside the slab and creating major horizontal cracks in the concrete. Under the balcony can be seen the network of hardened white calcified deposits, which have exuded through cracks in the concrete as a result of alkali-aggregate reaction. Photo: Lee H. Nelson, FAIA.

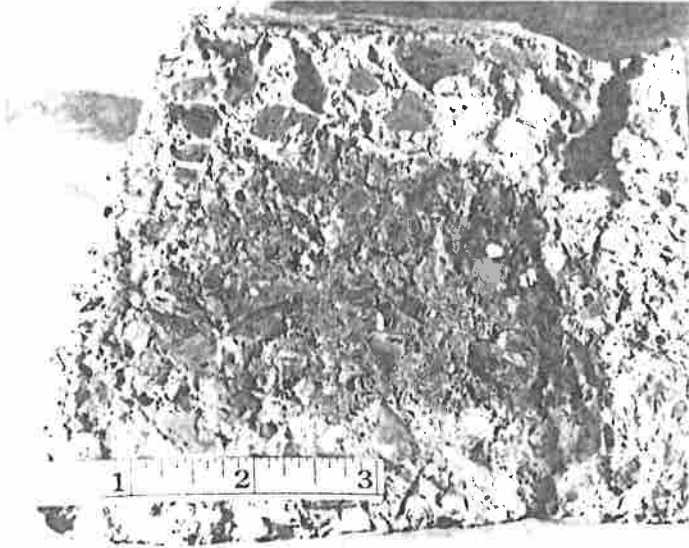
Fig. 10. Testing of actual samples of concrete in the lab may be necessary to determine the strength and condition of the concrete. In this sample, the surface, which is lighter than the sound concrete core, shows that carbonation has taken place. Carbonation reduces the alkalinity in concrete and may hasten corrosion of reinforcing bars close to the surface. Photo: Stella L. Marusin.

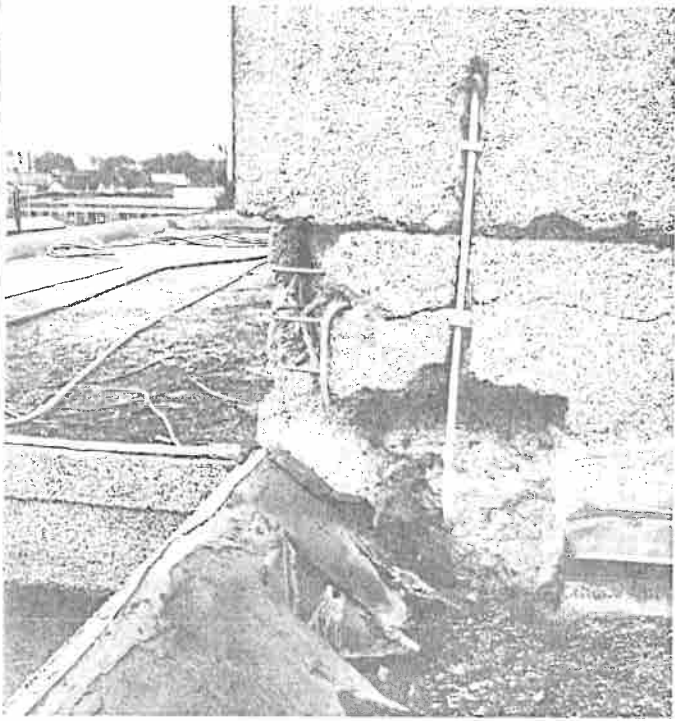
Fig. 14a. Spalled concrete was most noticeable at locations of concentrated rebars. Deteriorated concrete, the 1960s stucco finish, and corrosion were removed by grit-blasting. Photo: Robert Bell.

Fig. 14a-c. Unity Temple, Oak Park, Illinois (1906). Architect Frank Lloyd Wright used cast-in-place concrete with an exposed aggregate finish. However, reinforcing bars placed too close to the surface resulted in corrosion, cracking, and spalling. A superficial repair in the 1960s coated the surface with a concrete mix and Portland cement paint which produced a stucco-like finish and accelerated deterioration. Repair work was undertaken in 1971.

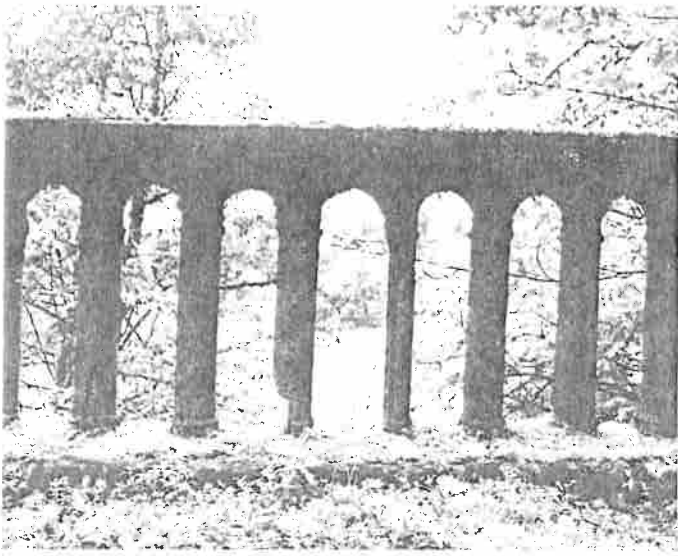
Fig. 15a. The spindle-type railings were deteriorated beyond repair. The concrete was cracked or broken and the center reinforcing rods were exposed and badly rusted.

Fig. 15b. Deteriorated spindles were removed. The original 1914 molds were still available and used in casting new concrete spindles, but had they not been available, new molds could have been made to match the originals.

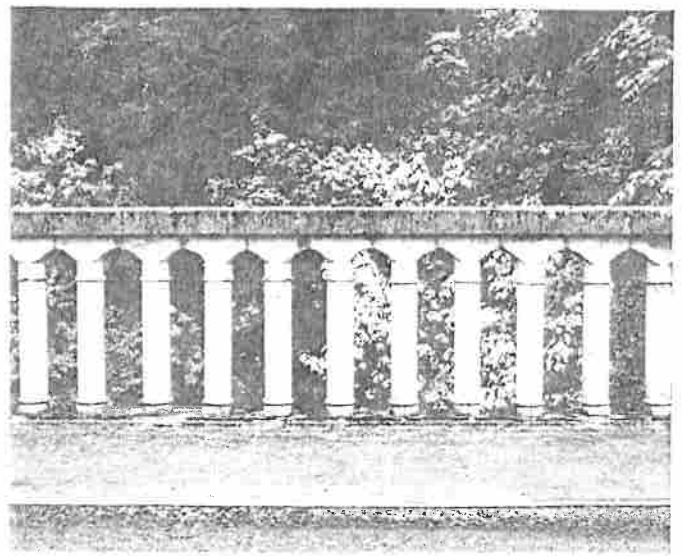
Fig. 15a-c. Columbia River Highway, Oregon. This historic highway overlooking the Columbia River Gorge was constructed from 1913 to 1922 and contains a number of significant concrete bridges. These photos illustrate the sensitive replacement of the concrete spindle-type balusters on the Young Creek (Shepperd's Dell) Bridge of 1914. Photos: James Norman, Oregon Department of Transportation.

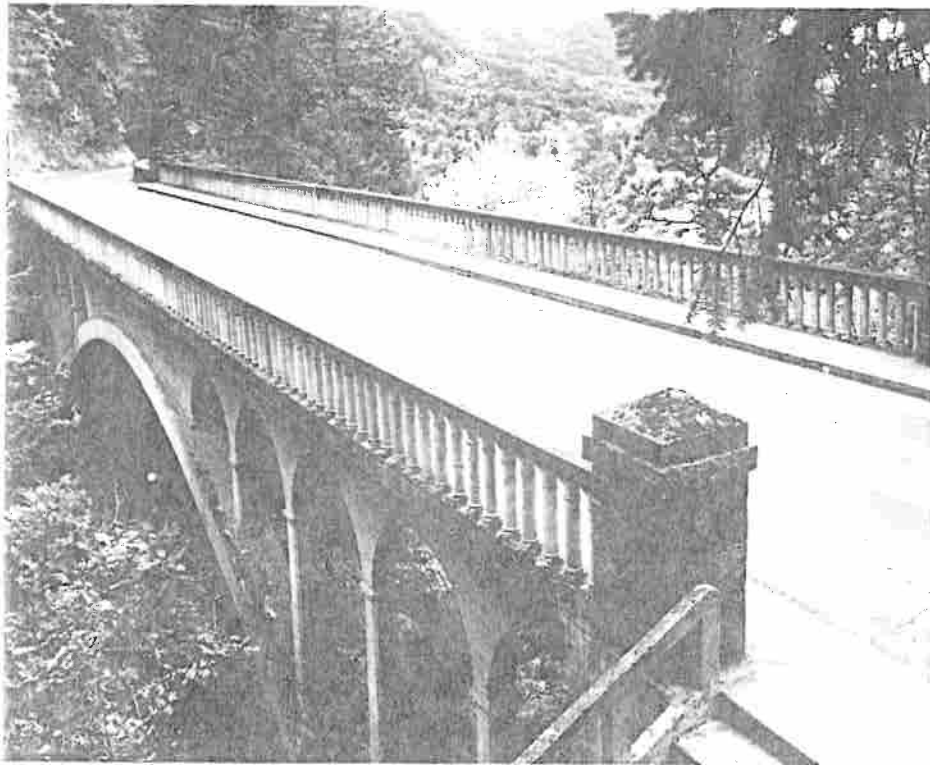
Fig. 15c. The new concrete spindles have been installed. This sensitive renovation reused the historic concrete cap railing and stone piers, as they were still in sound condition.
