# Historic Renovations and Additions to Memorial Auditorium- Burlington, Vermont

**FINAL REPORT**

Bargmann Hendrie + Archetype, Inc. January 31, 2019

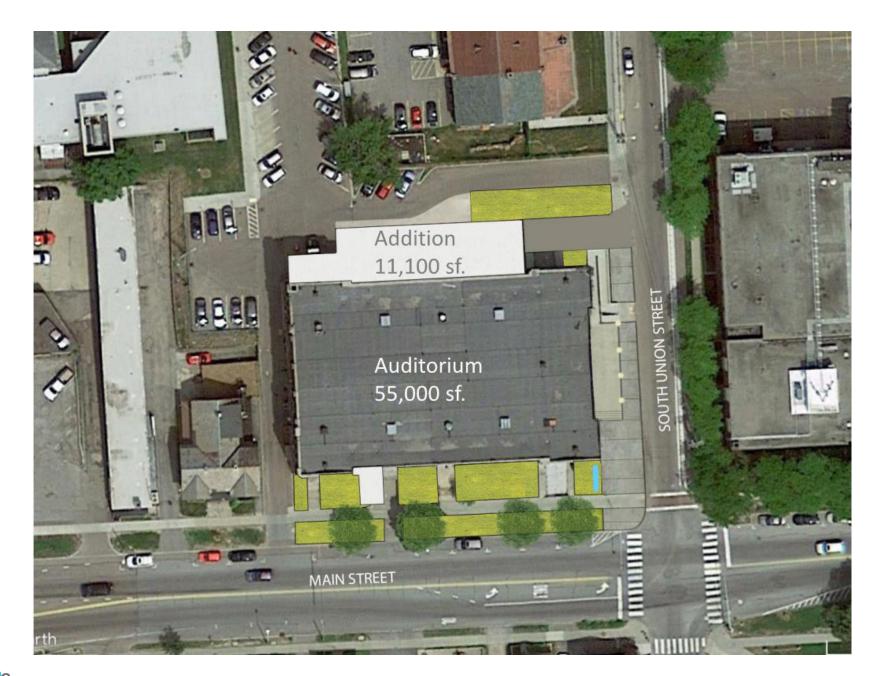
Site Plan

Site improvements are considered on three sides of the building. The entrance stairs to the building are to be demolished and rebuilt to current standards. Hard paving is expanded along South Union Street to accommodate large crowds. A digital signage panel is proposed at the corner of South Union and Main.

A proposed addition to the north includes loading for the Auditorium. The existing service drive is maintained to access trash and recycling functions and to access the Annex Level for servicing. The alley along the west side of the building is maintained for egress from the municipal parking lot.

The Design Team studied the ability for truck access to the north addition. All but the largest trucks can back into the proposed loading dock off of South Union Street. To accommodate loading by large tractor trailers (53'), modification to the dedicated bike lane along the east side of South Union Street will be needed in order to facilitate the turn back into the loading dock.

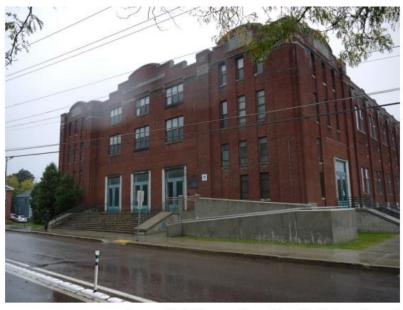
Accessible Ramp from South Union Street

The existing handicapped ramp is considered in good condition and is considered to remain in use. The entrance staircase and plaza is to be rebuilt to current standards using historically appropriate materials. A drop off area along South Union street is expected. The original marquee is to replicated.

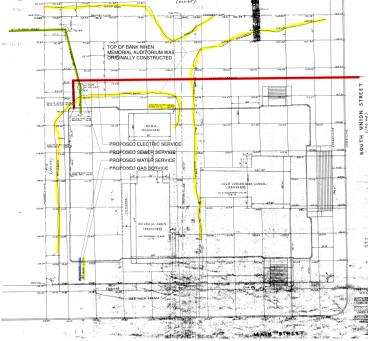
**Water**: The original 1926 site plan shows a proposed 4" waterline (highlighted blue below) to the building from Main Street at the west end of the south wall. The recent existing conditions mapping of the building does not show a water service line. The existing service line size and location should be confirmed from within the building. The condition of the waterline should be reviewed. If the original 1926 line is still in service, replacement should be considered. The existing pressure and flows to the building should be tested and the renovated and expanded building fire sprinkler requirements should be evaluated and compacted to existing capacity. If the capacity is not adequate, a new, larger water service line should be considered. **Assume 50lf of 6" ductile iron waterline from the building to Main Street for budget purposes.**

Original 1926 site plan with pre-existing buildings, grades and proposed utilities shown.
