GENERAL BUTLER, SHIPWRECK
BURLINGTON

The shipwreck of the *General Butler* is a Lake Champlain sailing canal schooner of the 1862 class, built after an enlargement of the Champlain Canal and its locks (Figure 1). The vessel was built in 1862 in Essex, New York, by local shipwrights John Hoskins, Wesley J. Hoskins, and John Ross using a chine log construction technique. This shipbuilding technique was commonly practiced by Champlain Valley boat builders for many different types of vessels and was the predominant technique used to build sailing canal boats. After fifteen years of service on Lake Champlain, the vessel accidentally struck the Burlington breakwater and sank in 1876. The *General Butler* sits upright on the sandy lake bottom nearly intact in 35 ft (10.7 m) of water 300 ft (91.5 m) west of the breakwater (Figure 2). The vessel's masts, spars and blocks were removed from the vessel shortly after it sank. Today the vessel remains in nearly the same condition as when it sank, except for slight erosion and corrosion, and silt within its hold.

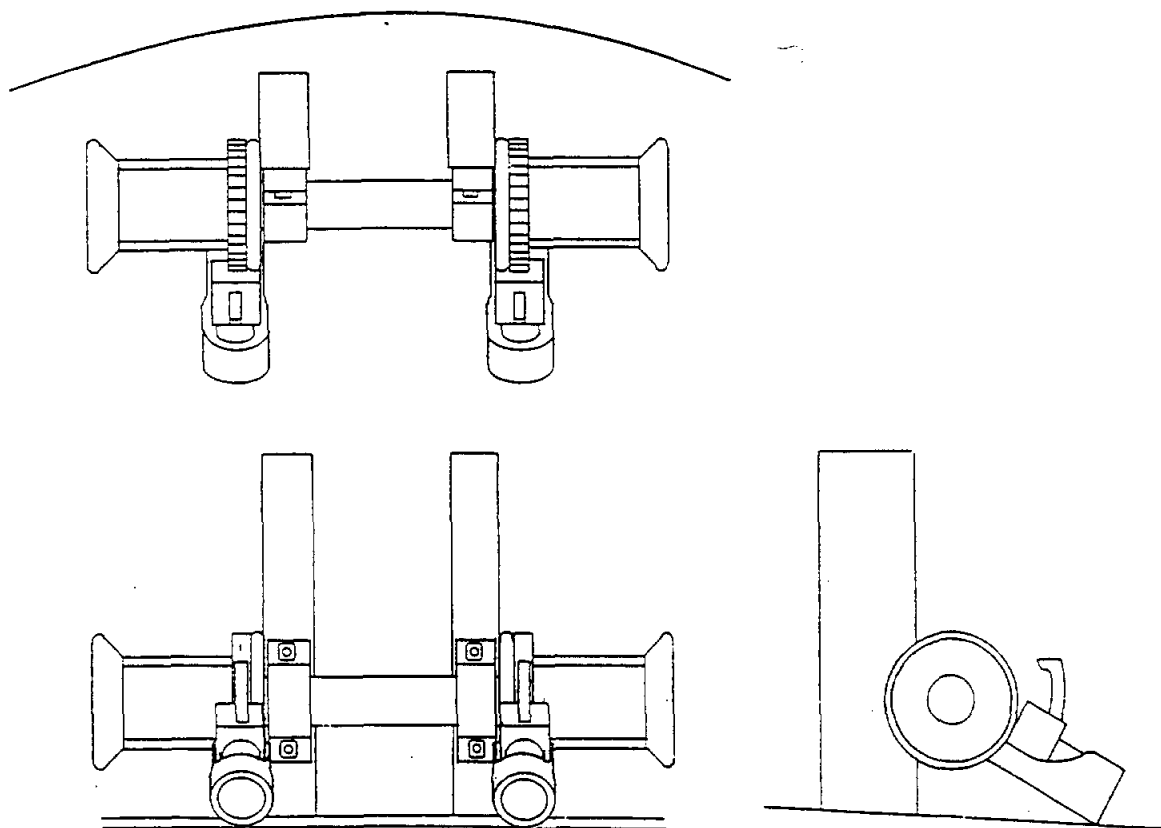
Figure 5: Three views of the *General Butler's* windlass (drawn by Joseph R. Cozzi, 1995)

second appears to be obscured by other timbers. The 1 in (2.5 cm) head of the visible fastening suggests a 0.75 in (1.9 cm) diameter through bolt secured by a nut placed in a square cutout in the rub plate. No fastenings between the apron and keel plank were noted. However, the 1 in (2.5 cm) heads of two iron fastenings in the upper face of the keelson suggest drift bolts that pass through the apron and into the keel plank. The upper face of the apron also supports the base of two white oak windlass bitts (Figure 5).
