STATE OF VERMONT Division for Historic Preservation Montpelier, VT 05602 HISTORIC SITES & STRUCTURES SURVEY Individual Structure Survey Form	SURVEY NUMBER: 0402-5
	Part of: <input type="checkbox"/> District _____ <input type="checkbox"/> Complex _____
COUNTY: Chittenden	Contributing <input type="checkbox"/> Non-Contributing <input checked="" type="checkbox"/>
TOWN: Burlington VILLAGE:	Listed on: State Register of Historic Places National Register of Historic Places
LOCATION: 69 Charlotte Street	CRITERIA: A <input type="checkbox"/> B <input type="checkbox"/> C <input type="checkbox"/> D <input type="checkbox"/>
PROPERTY TYPE: House	NEGATIVE FILE NUMBER:
OWNER: Amy & Karen Bielawski Branch ADDRESS:	COORDINATES: UTM (ZONE 18) E 0 N 0 VSP (NAD 83) E 443340.41042 N 218575.81736 E911 E N
ACCESSIBILITY TO PUBLIC: Yes <input type="checkbox"/> No <input checked="" type="checkbox"/> Restricted <input type="checkbox"/>	PRESENT FORMAL NAME: Bielawski Branch House

HISTORIC CONTEXT: Physical Patterns of Communities	COMMON NAME: Bielawski Branch House
SIGNIFICANCE: Architectural <input type="checkbox"/> Historic <input type="checkbox"/> Archeological <input type="checkbox"/> Engineering <input t

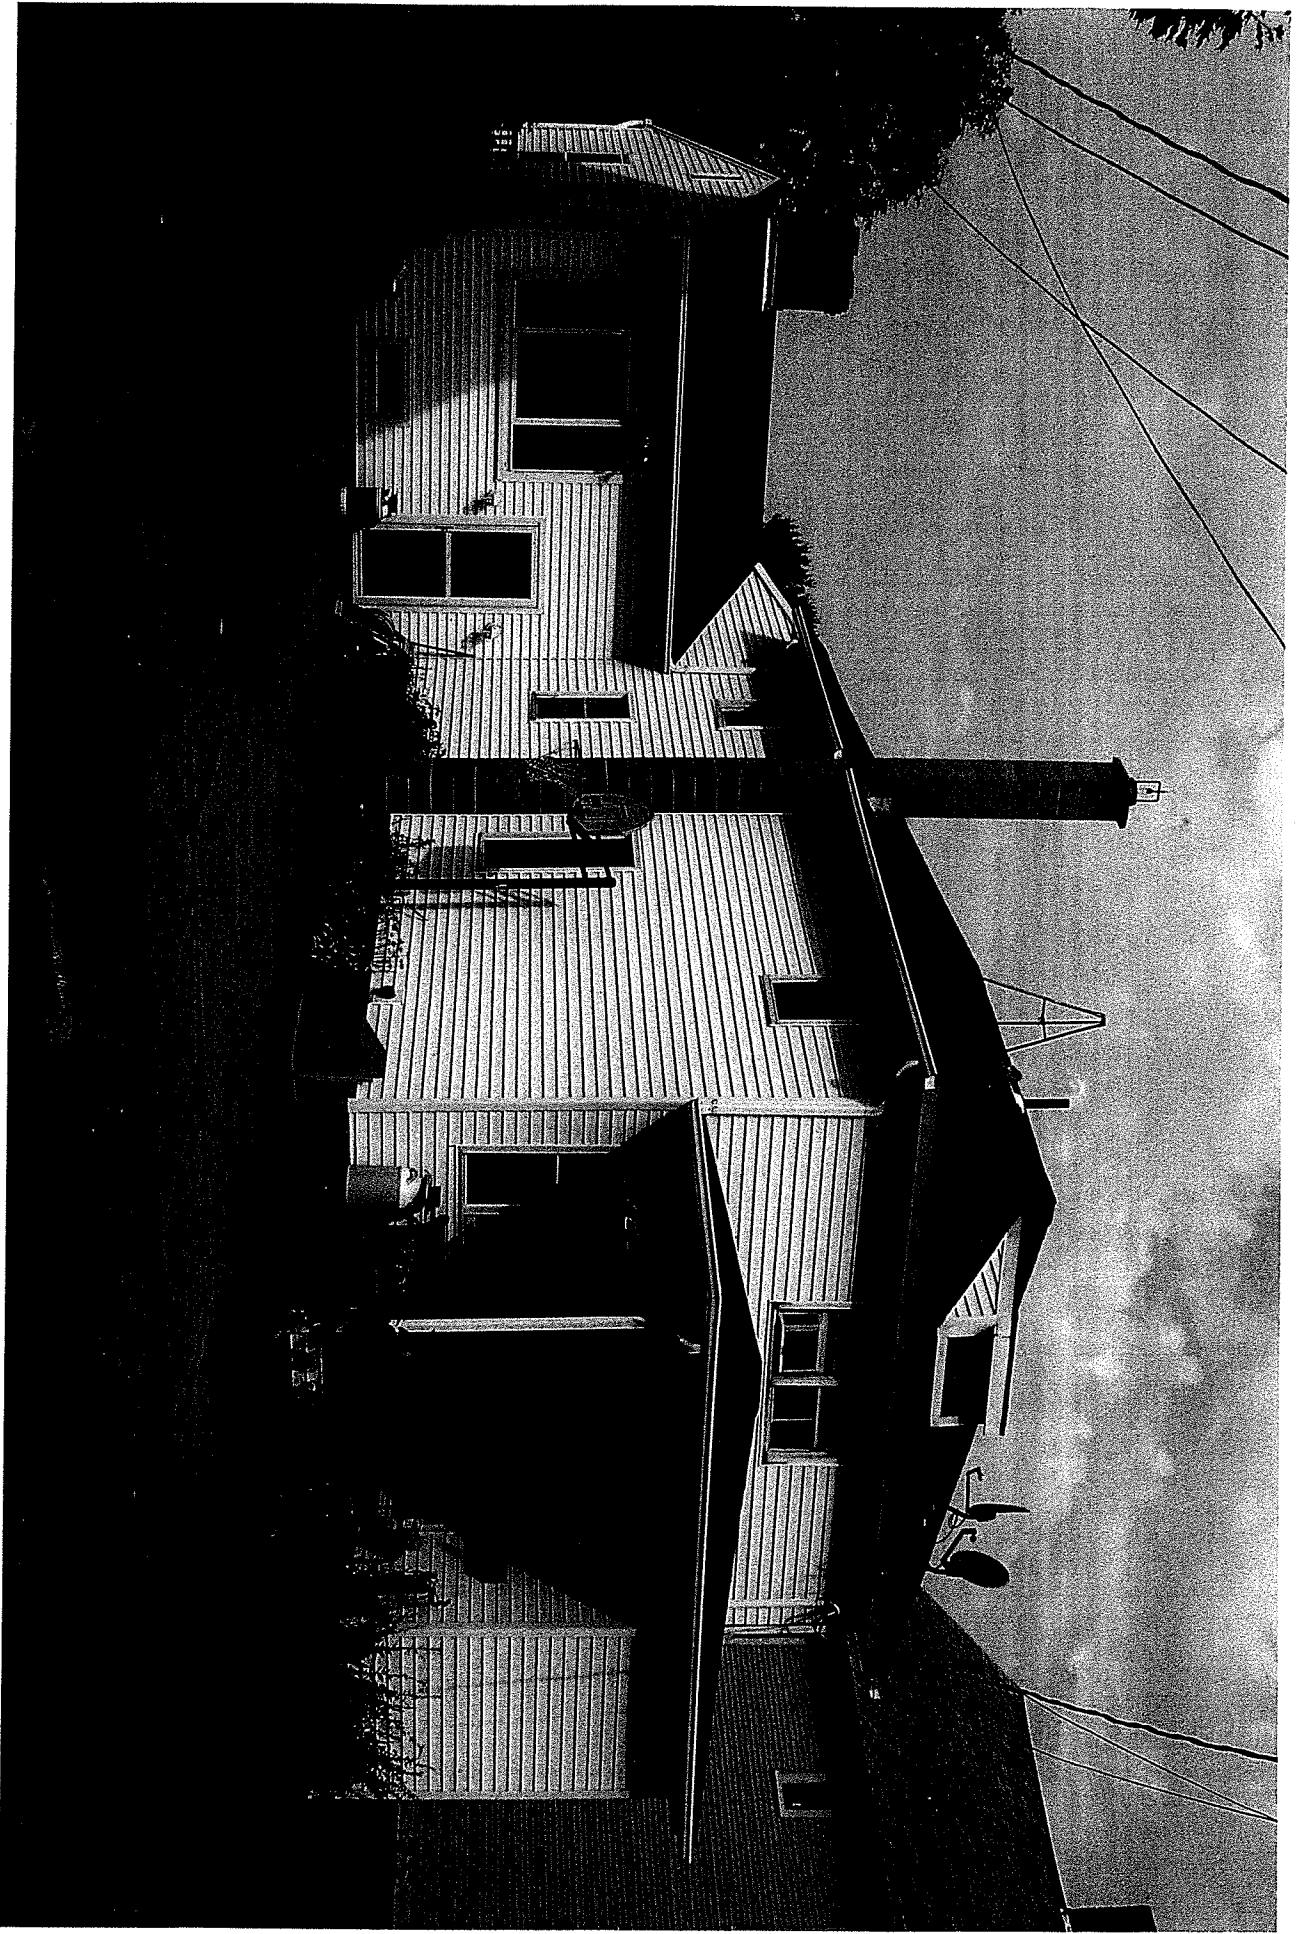
Original full-width porch is partially enclosed on the right side and the entry door turned 90 degrees. Large additions off the rear and side of the hosue make it a non-contributing resource.

Survey 0402-5: 69 Charlotte Street
Burlington, VT. View northwest.
Photograph by Devin Colman, 9/5/2007
Digital image on file at VT Division for Historic Preservation
